**SAYERS FARM HADLEIGH  
ESSEX**

**Built Heritage Appraisal**

On behalf of:  
**Essex County Council**

Report reference: 79790.01

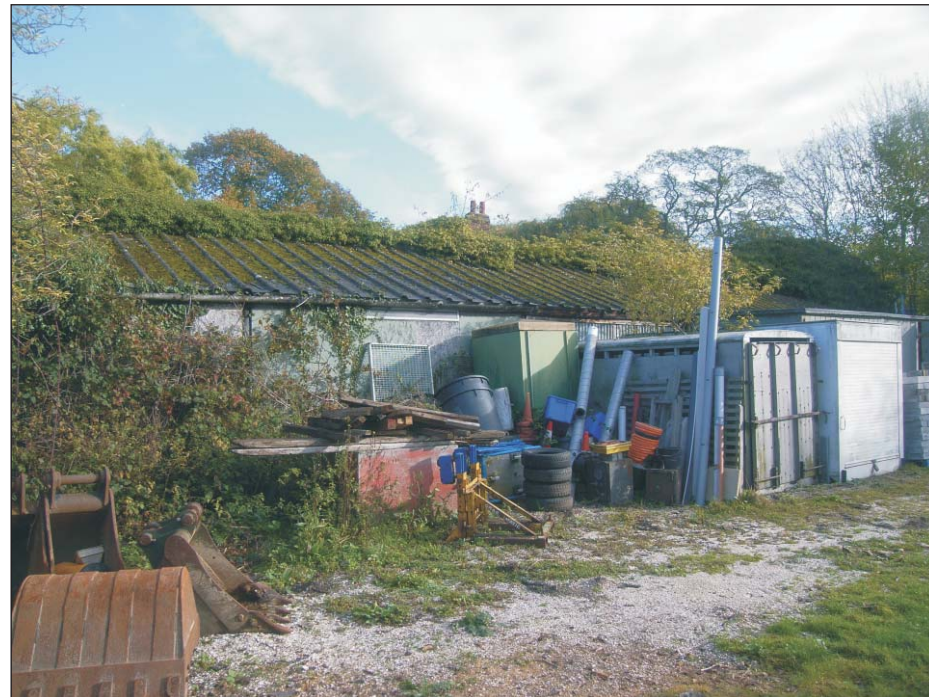
- 3.10.1 Single storey pitched roof covered in interlocking profiled asbestos sheeting similar to that seen on roof of building D (**Plate 12**). Rear north wall constructed in brick with south open front of five bays formed by cast iron circular stanchions supporting light weight iron roof trusses. South front has been infilled by tenant which has obscured some of the detail of the building's appearance. The roof trusses are formed from 'L' sections of iron held by bolted connecting brackets forming 'Fink' profiles (**Plate 13**). Double wooden sheet purlins are fixed to angled strut extensions welded to the main truss struts. The feet of the trusses are set on pad stones built into the north wall and directly onto the cast iron posts on the south side (**Plate 14**). There is some evidence that the truss feet have been cut back where they meet the cast iron post tops (**Plate 15**). The plates have been cut back crudely so that the plates do not extend into the open bay. The inside of the building is largely obscured by stored equipment and materials but there is some evidence of demolished internal partitions (**Plate 16**). The floor is concrete

Plate 12: Building C - South elevation

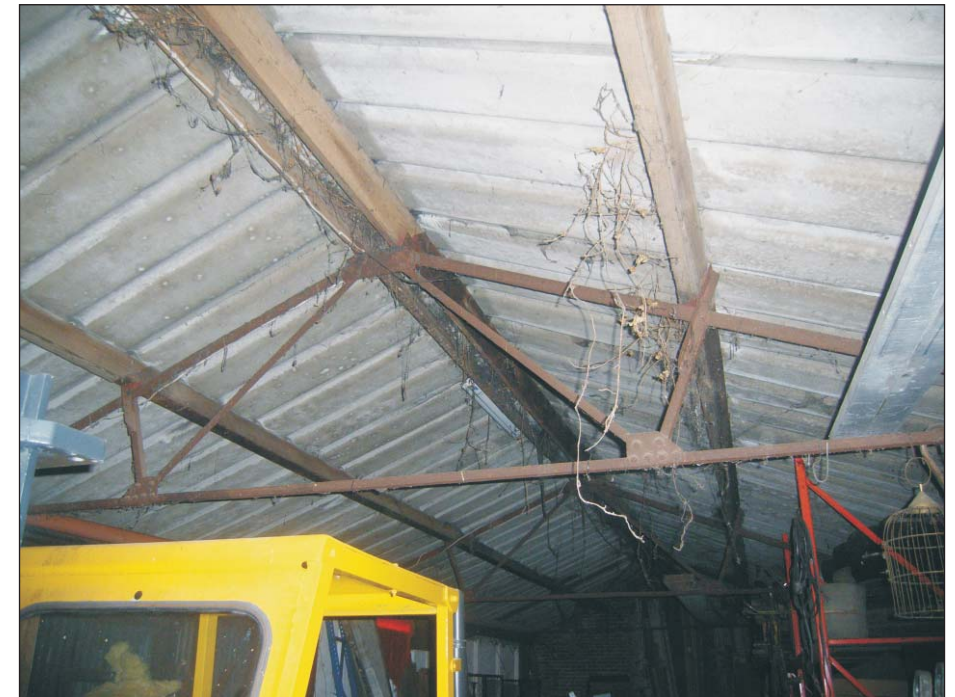
Plate 13: Building C - Interior showing roof truss

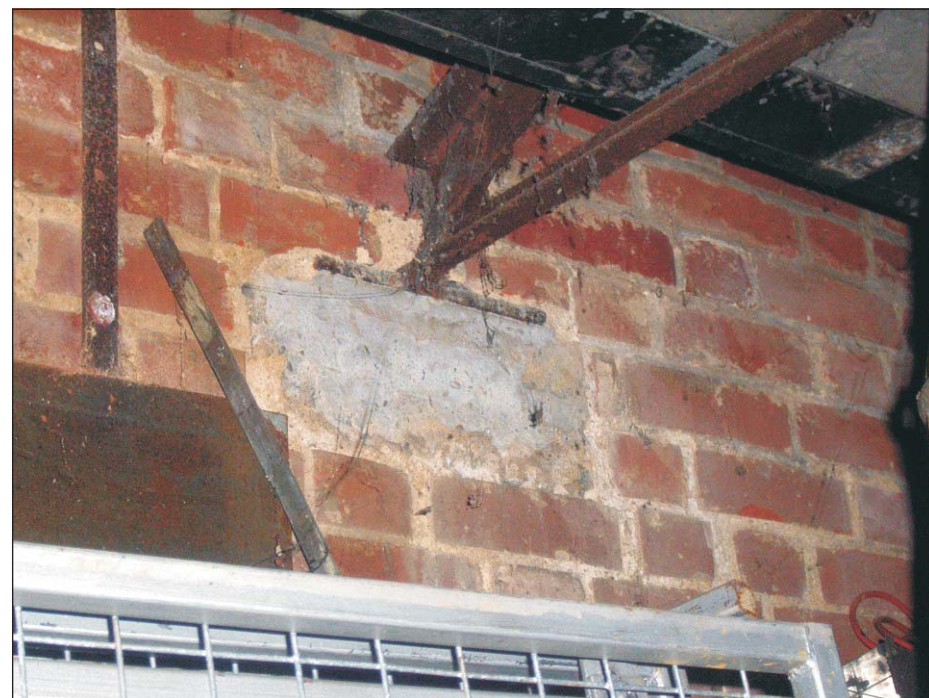
Plate 14: Building C - Interior. Rooftruss resting on padstone in north wall

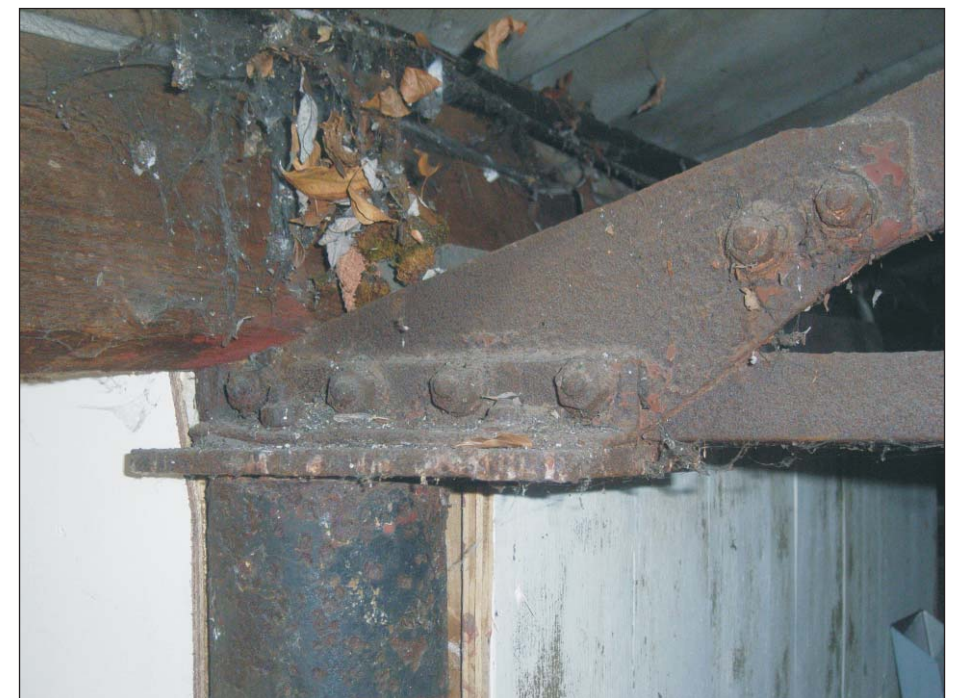
Plate 15: Building C - Interior. Roof truss resting on cast iron column showing cut back edges

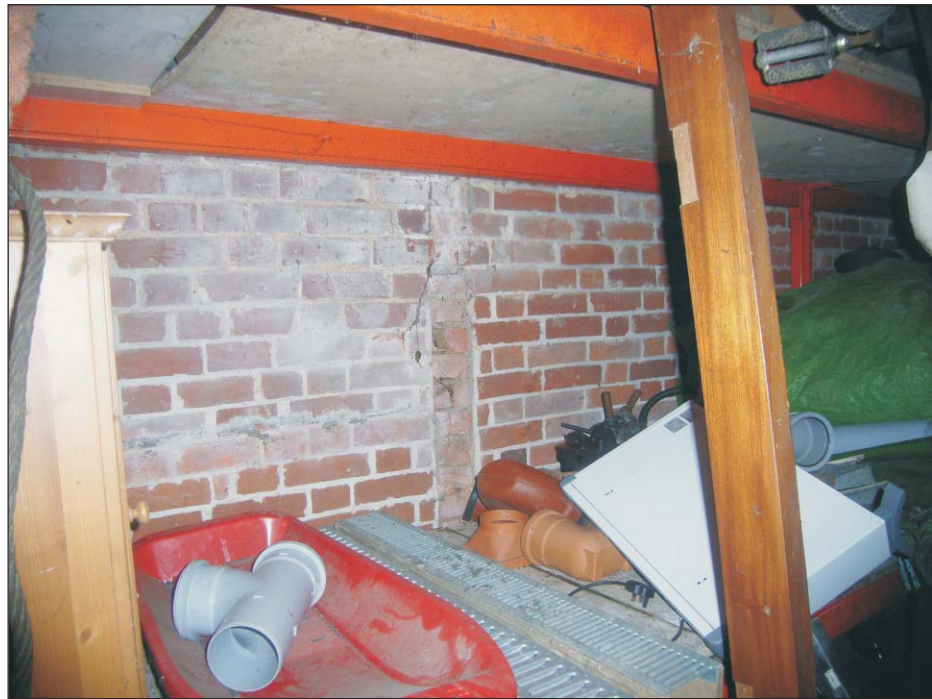
Plate 16: Building C - Interior. Evidence of removed partition

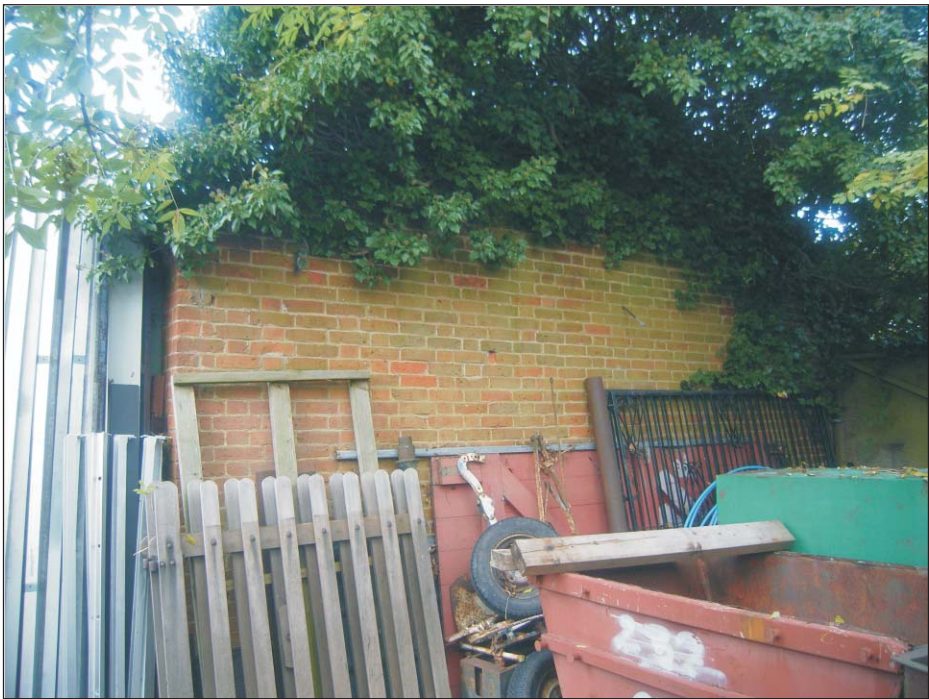
and the external yard surface has been built up. The east gable end is visible and constructed in characteristic local red bricks with inclusions of pebbles and small stones. They were laid in Monk bond similar to those found in the gable of Building D (**Plate 17**).

Plate 17: Building C - East gable brickwork

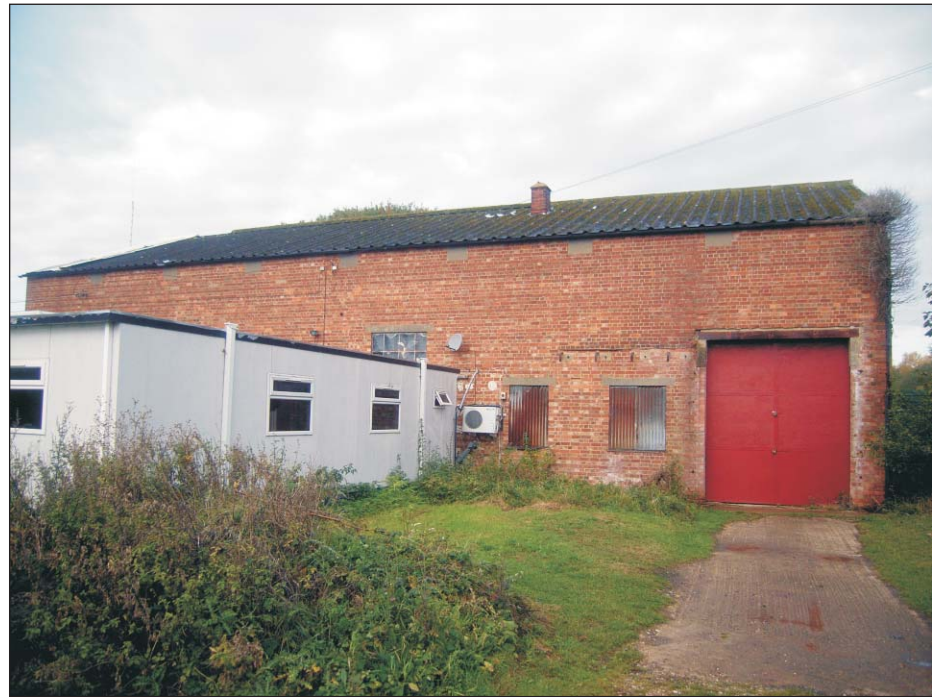
- 3.11.1 Large two storey building with pitched roof covered in interlocking profiled asbestos sheeting similar to that seen on Building C (**Plate 18**). Walls probably 13 inch wide are constructed from local bricks in English bond. The gables are built in 9 inch Monk bond similar to that seen in the gable of building C. The various window openings are fitted with metal framed windows with cement covered brick flat arches. Visible at eaves level below the roof are pad stones which probably support the internal roof trusses. Locally described as the 'brick kiln', iron rails set in concrete were seen to enter the building through a wide door opening in the south-east corner. This building is probably part of the brickwork complex noted on the 1960 OS plan.

Plate 18: Building D - East elevation

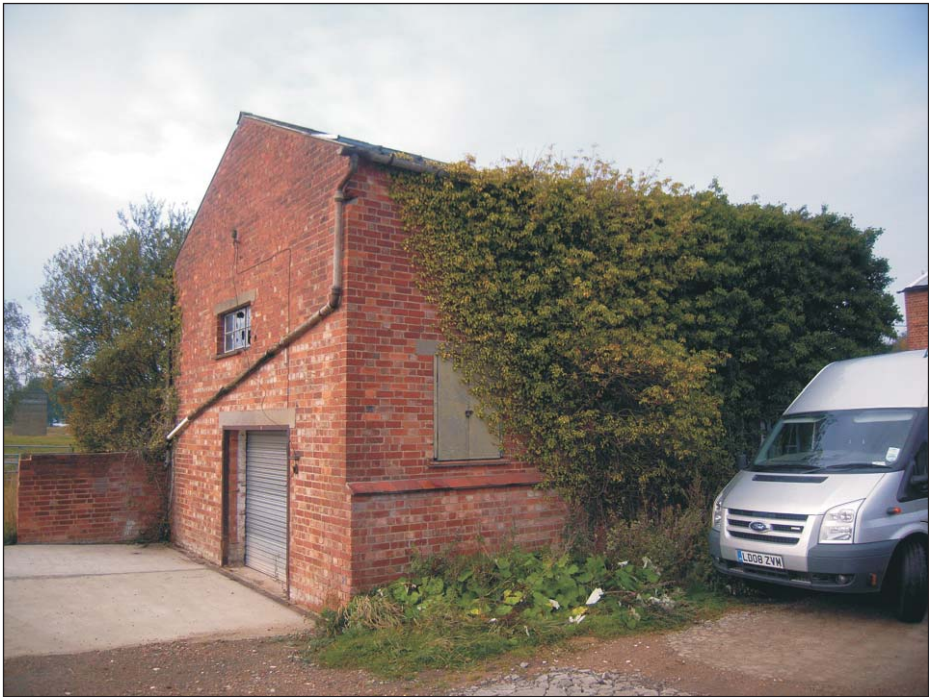
- 3.12.1 Smaller two storey building but probably contemporary with building D. Constructed in similar bricks it too has 13 inch English bond walling with Monk bond Gables. The pitched roof is also covered in interlocking asbestos sheeting (**Plate 19**). The building has a plinth along the north side but this largely obscured by ivy growth. Locally known as the 'fan room' it was probably involved in the drying of bricks and formed part of the once co-joined brickwork buildings seen on the 1960 OS map. The various window openings are similar to those seen in building D with metal frames and cemented brick lintels. The wide door opening in the east end of the building may have been used for rail access.

Plate 19: Building E - East and north elevations

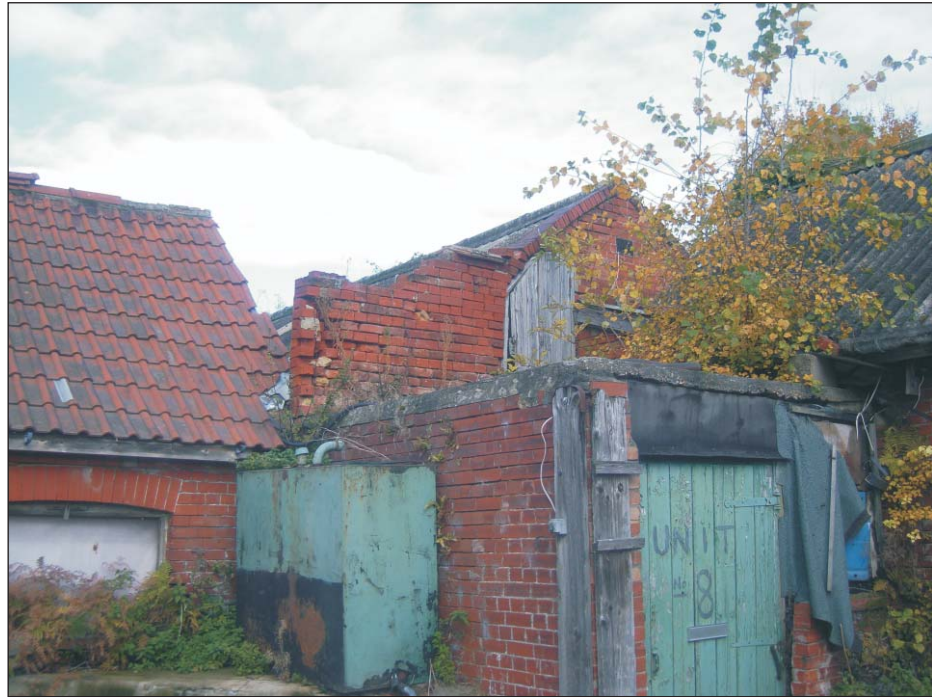
- 3.3.1 Largely obscured from the outside by later buildings added to south front and undergrowth along its north side. Comprising single storey red brick construction with pitched roof covered in corrugated asbestos sheeting (**Plate 4**). Probably represents the earliest surviving farm building on the site as it is depicted on 1840 Tithe map.

Plate 4: Building A1 - East gable end

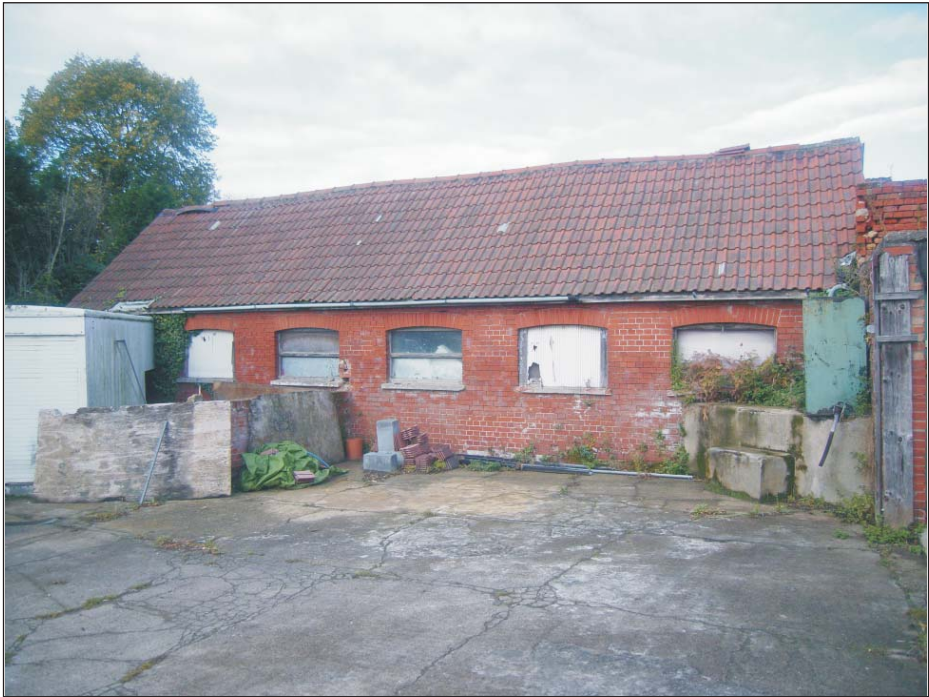
- 3.4.1 Single storey red brick in strong English bond under a pitched roof covered in red clay pan tiles (**Plate 5**). Five evenly spaced window openings along east elevation have brick soldier arches over with some survival of wooden window frames. Yard to east concreted over. First appears on 1896 OS map and is probably part of Salvation Army dairy buildings. Remains of bull pen visible in south-west corner of yard.

Plate 5: Building A2 - East elevation

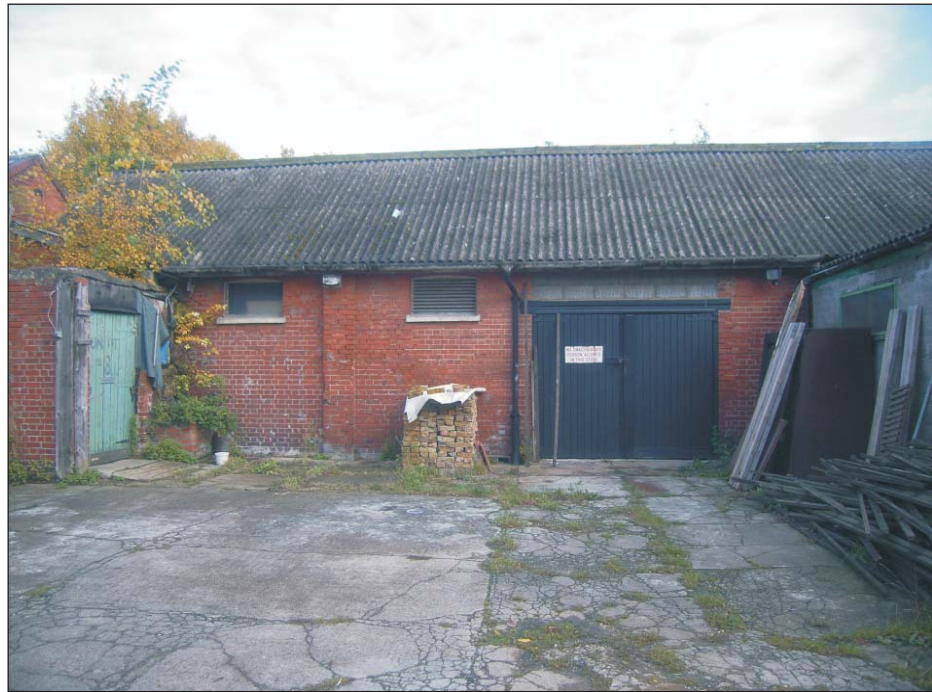
- 3.5.1 Single storey red brick in strong English bond under a pitched roof covered in corrugated asbestos sheeting (**Plate 6**). 'L' shaped plan form with cambered arch window openings with some metal framed windows along

Plate 6: Building A3 - South elevation

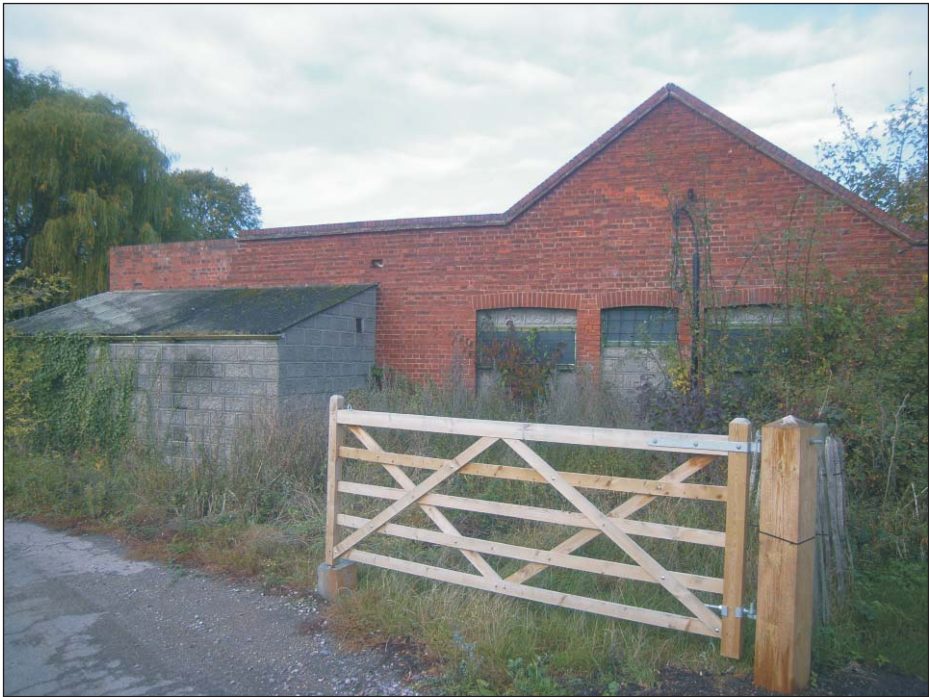
the exposed east elevation (**Plate 7**). South facing exposed section of elevation has a brick pier and small window openings at high level. Also a contemporary double door entrance with modern alteration over. The door would appear to be contemporary as the brick bonding has the requisite closers. It first appears on the 1896 OS map and is therefore likely to be one of the Salvation Army's dairy buildings. Similar in appearance to A2.

Plate 7: Building A3 - East elevation

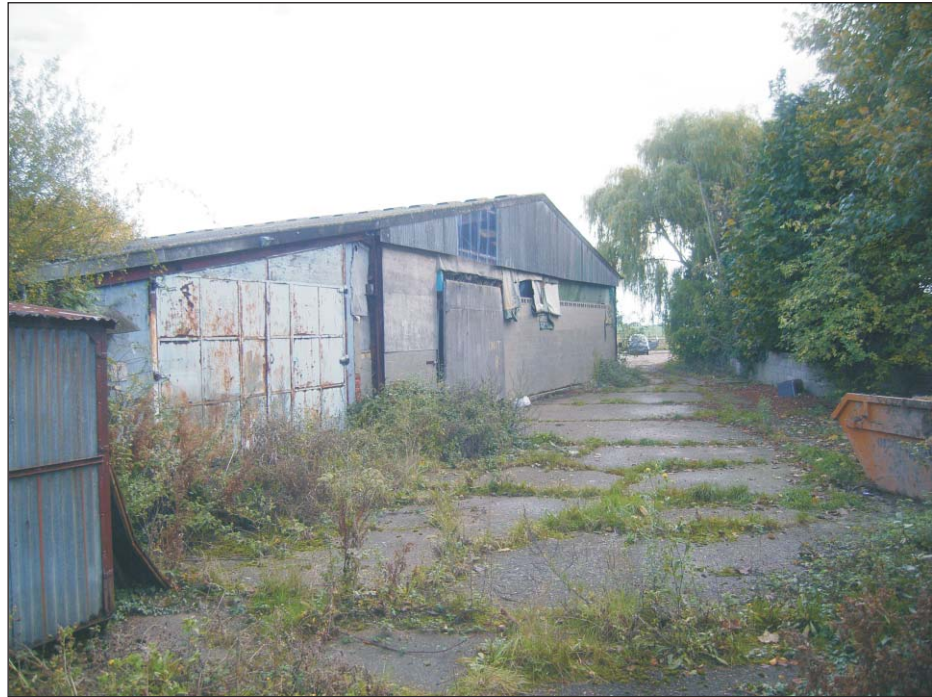
- 3.6.1 Seen only from the outside, it is a large square portal steel framed barn with concrete block curtain walls (**Plate 8**). Low pitched roof covered in asbestos sheeting and may have been partly built over building to north-west. First appears on the 1960 OS map.

Plate 8: Building A4 - South elevation

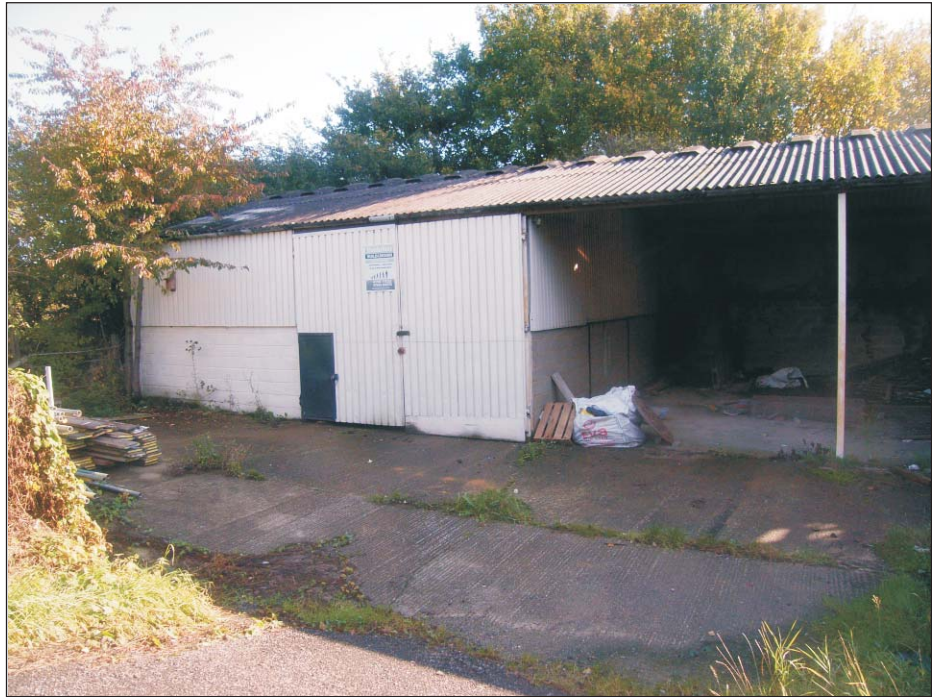
- 3.7.1 Modern part open steel framed store to north of main farm buildings. Concrete apron and floor and partly enclosed sections with concrete blocks (**Plate 9**). Does not appear on 1967-68 OS mapping (not shown in this report).

Plate 9: Building A5 - North-west elevation

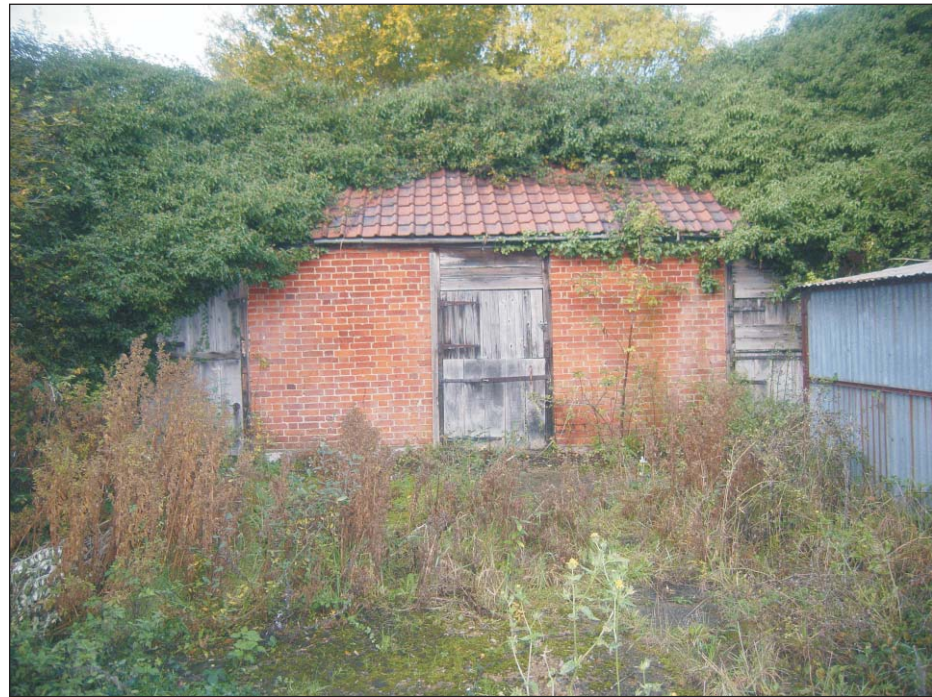
- 3.8.1 Small red brick built stable block in Monk bond with three stable door openings. Pitched roof covered with red clay pan tiles similar to those seen on A2 (**Plate 10**). Double slate damp course visible and the doors are probably later replacements as door furniture is of different styles. No access to interior. First appears on 1896 OS map and is therefore likely to date from Salvation Army's development of the farm. Largely overgrown with ivy.

Plate 10: Building B stable - East elevation

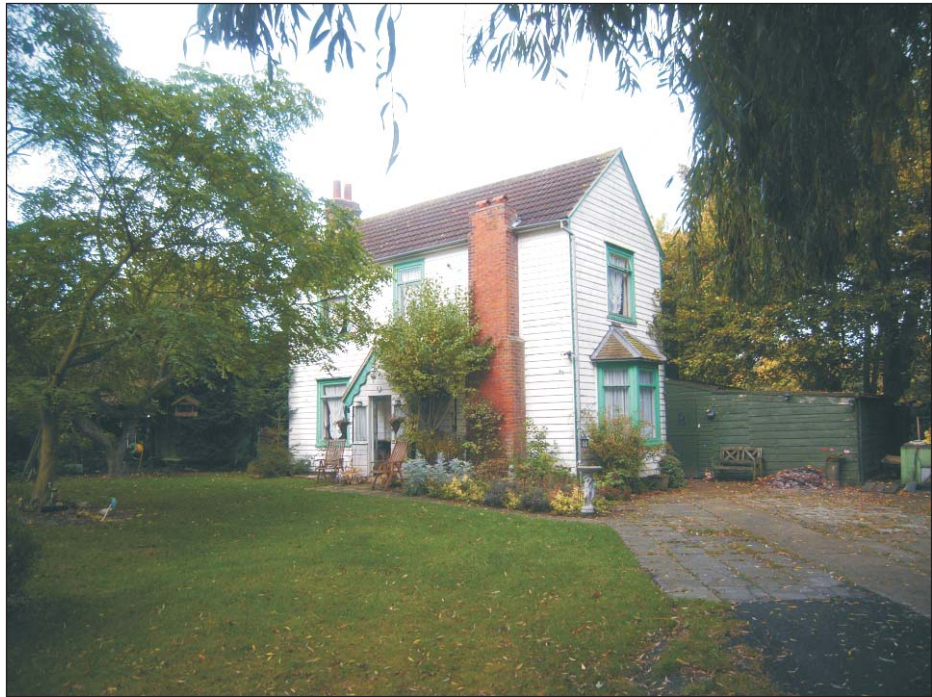
- 3.9.1 Two storey farmhouse under pitched roof covered in red interlocking tiles (**Plate 11**). Timber framed with overlapping weather boarding typical of the Essex area it is locally listed as a building of interest. Two visible brick chimney stacks. Narrow plan form with central stairwell. Some timber framed single storey store sheds to north. A farm house is first seen on 1840 Tithe map and not seen on 1777 map. This house may date to 1870 as a re-build (Wessex Archaeology 2010).

Plate 11: Farm house - residential dwelling
