Tree Survey

1 Copper Beeches, Benfleet, Essex

Arbtech Consulting Limited were instructed to attend 1 Copper Beeches, Benfleet, Essex, SS7 3UA (site) on 4th October 2013 to document the finding of the of the tree survey and produce a tree location plan and schedule of tree works (if required).

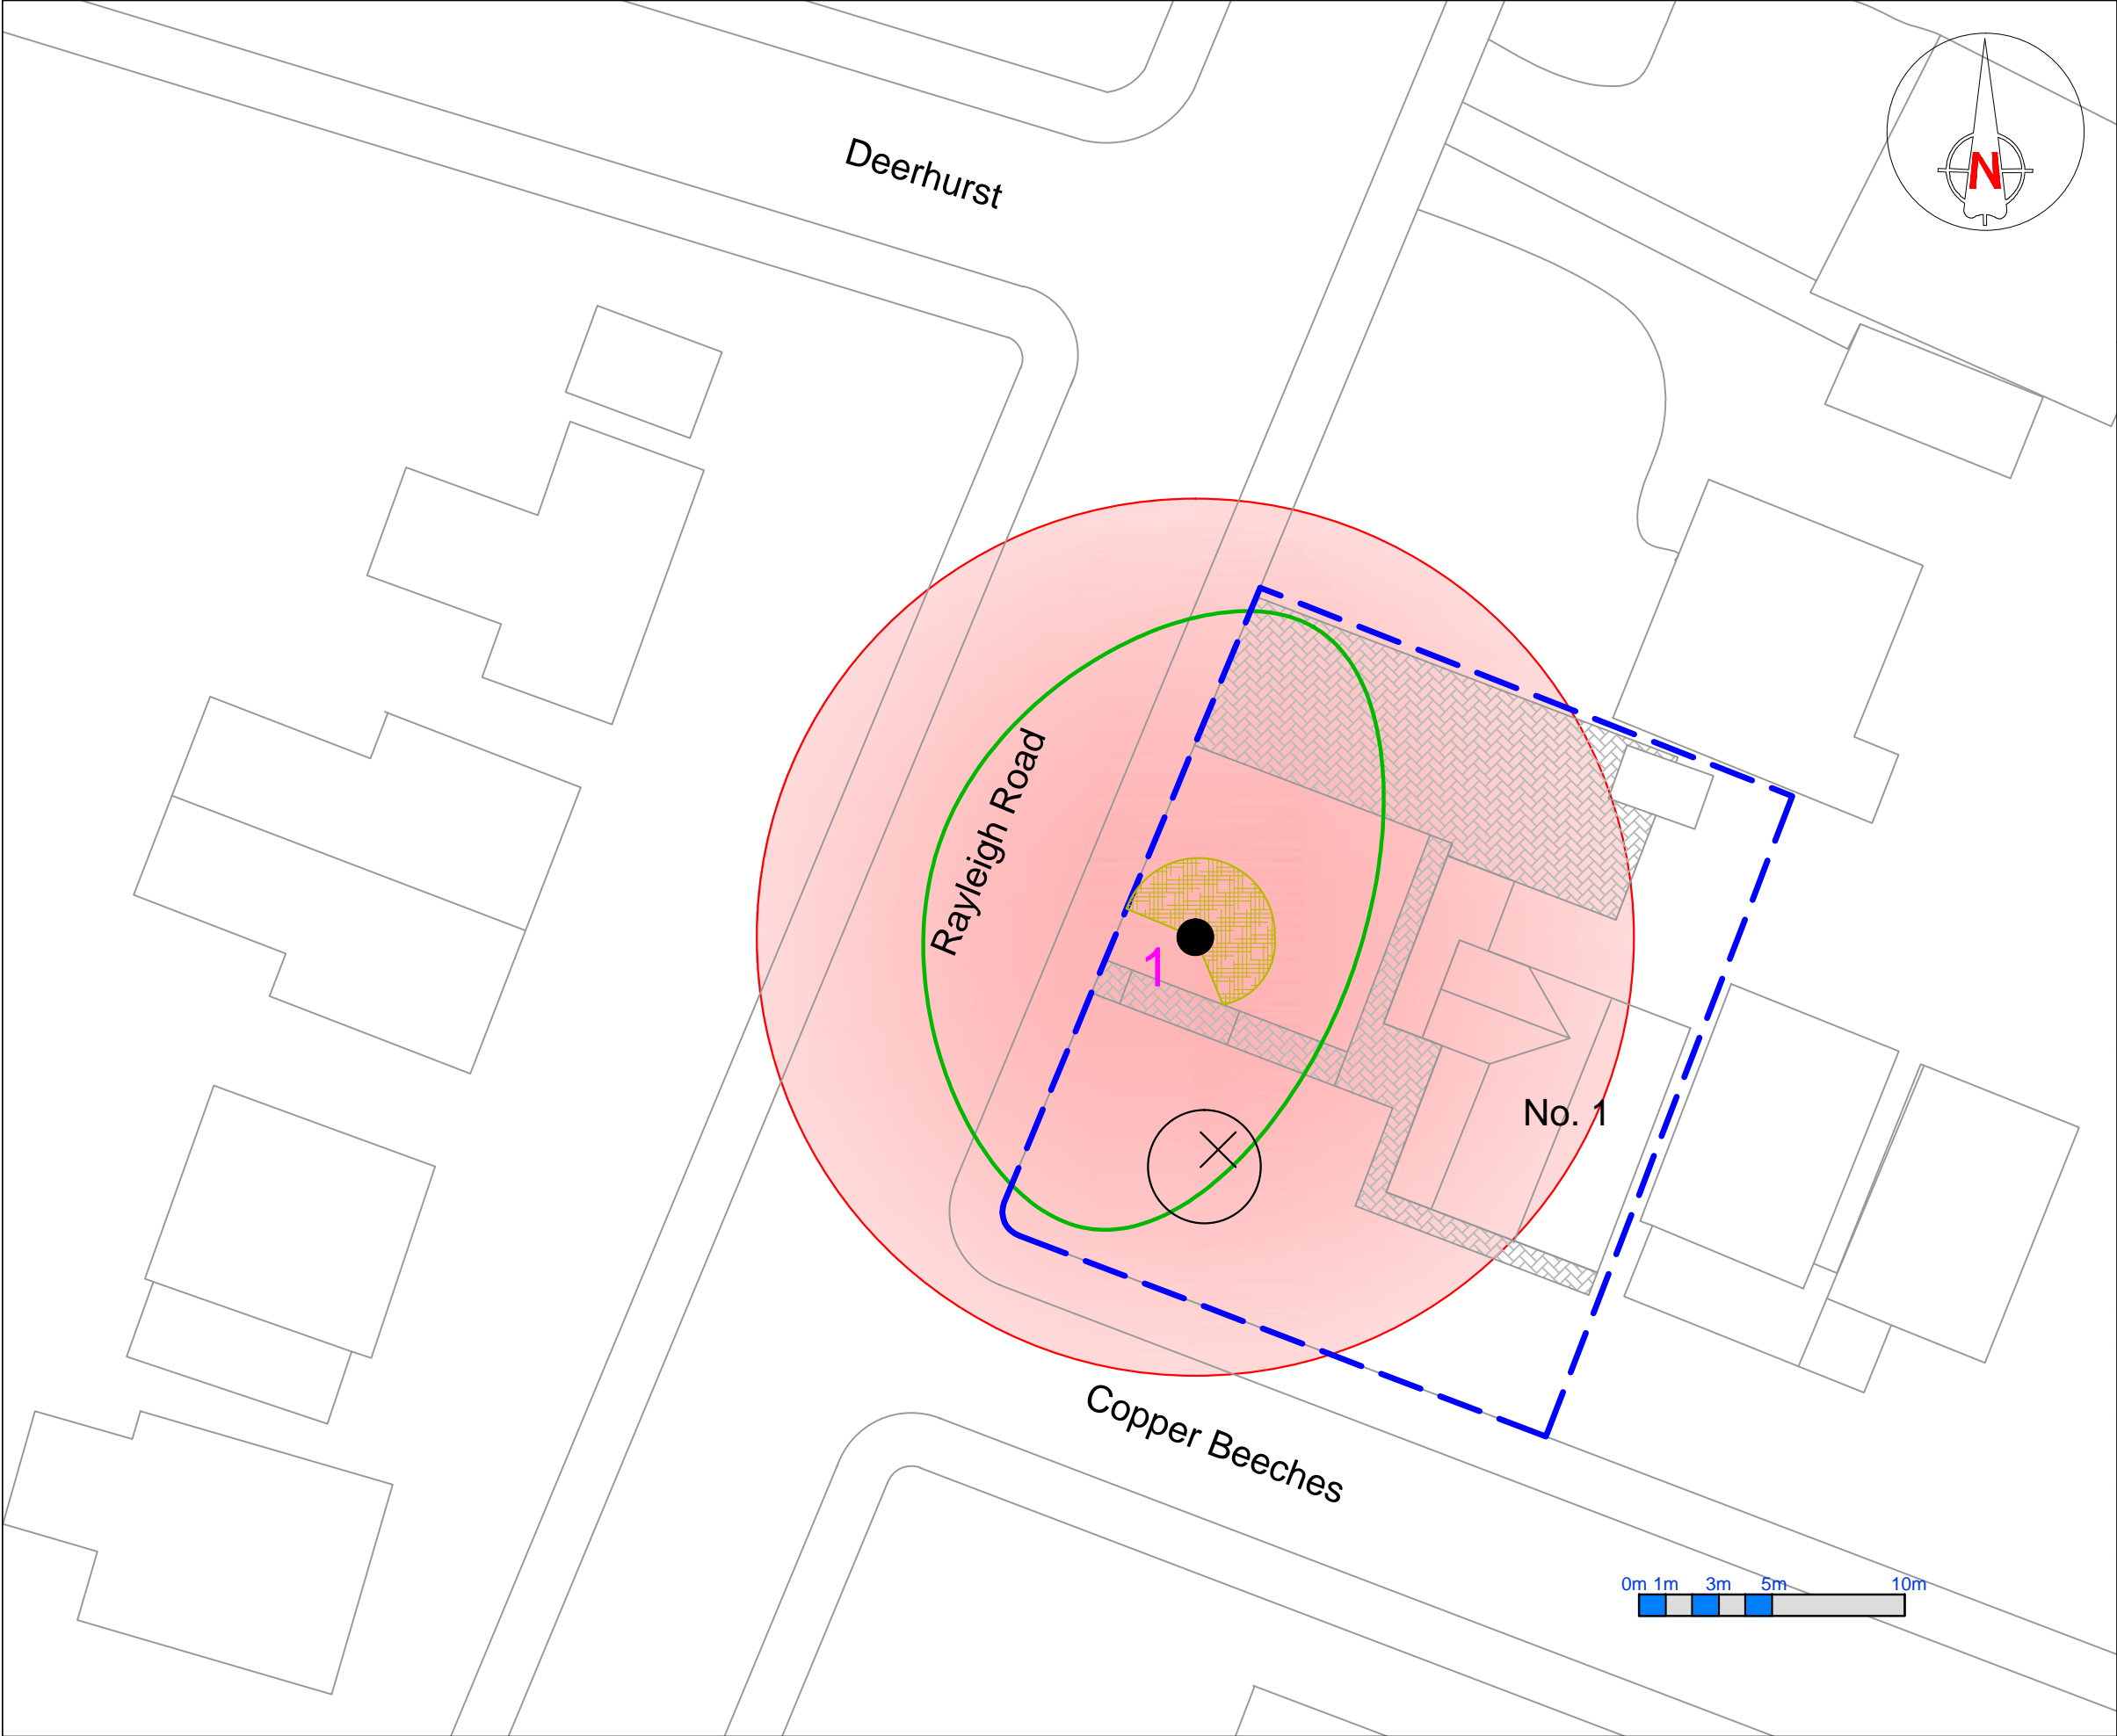
Appendix 2: Tree Location Plan

The copper beech tree was situated within the raised front garden (approximately 850mm above the footpath and A129) of No.1 Copper Beeches and within 2.25m from the public footpath and 4.8m from the edge the A129.

Due to the condition of the tree and the proximity of the tree to the public footpath and A129 the tree fell within the High category of the Hazard Zone Categories.

The public footpath and A129 are situated along the boundary of the site and were also situated underneath the edge of the canopy of the tree. Due to the level, quantity and size of the fungal fruiting bodies (*Meripilus giganteus* – giant polypore), their spread and the below average physiology of the tree I believed the infestation of the *M.giganteus* was in the later stages and had spread from the deeper roots to the surface roots and as such the tree was at a greater risk of collapse which due to the unsymmetrical shape, the spread and the weight of the canopy over the road was likely if the tree was to collapse/uproot it would have been in the direction of the A129.

It was therefore my recommendation that the best course of action was to remove the tree and provide replacement specimen.

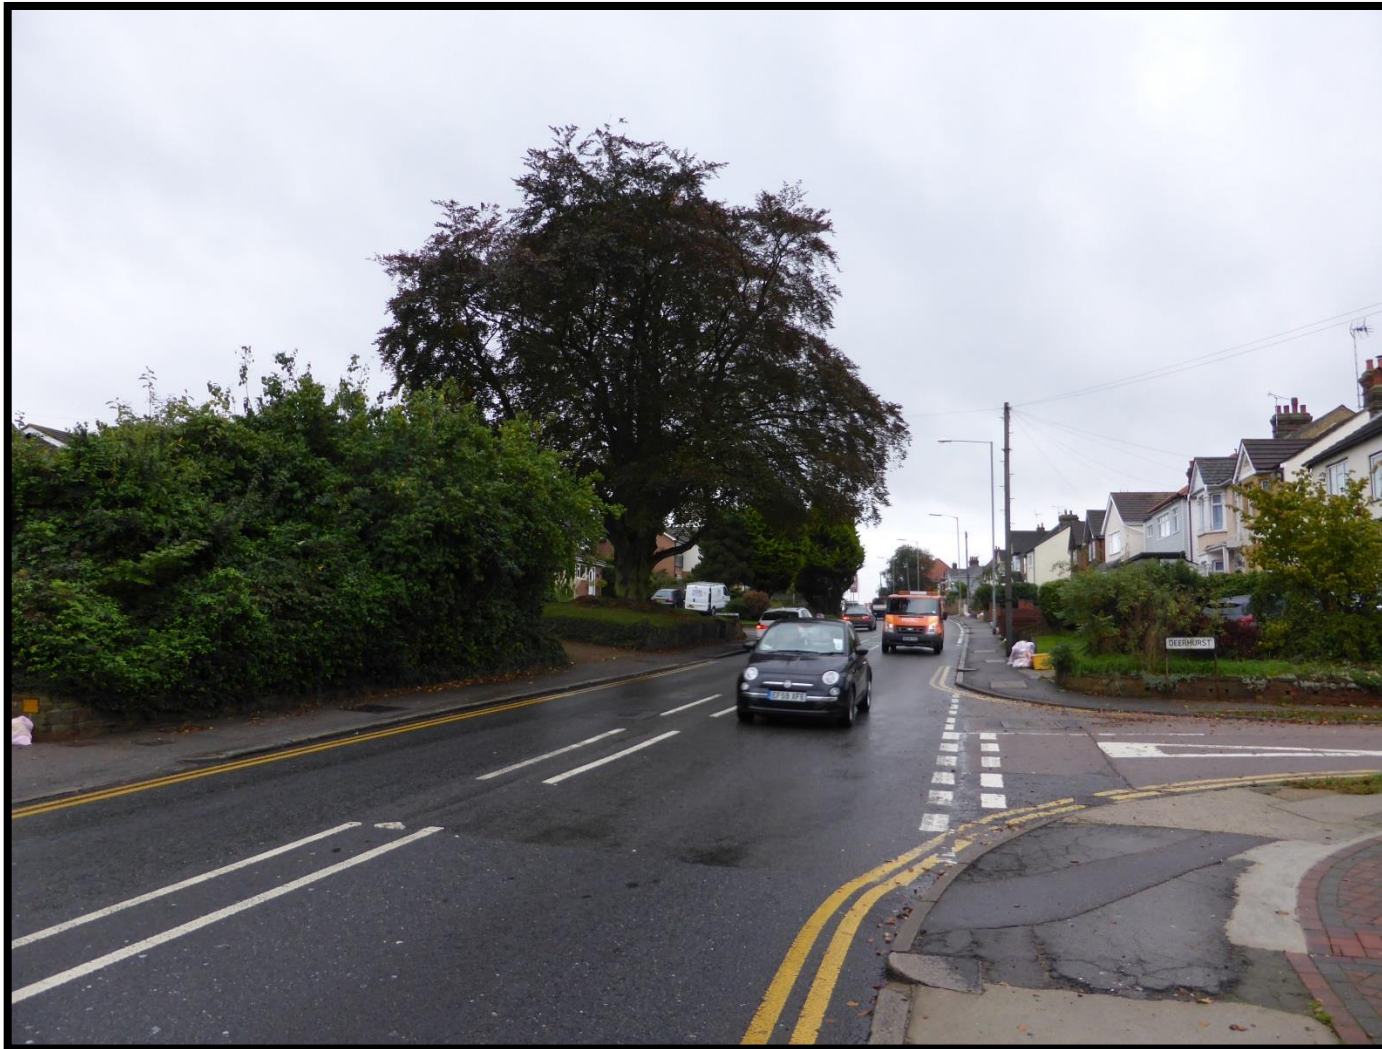
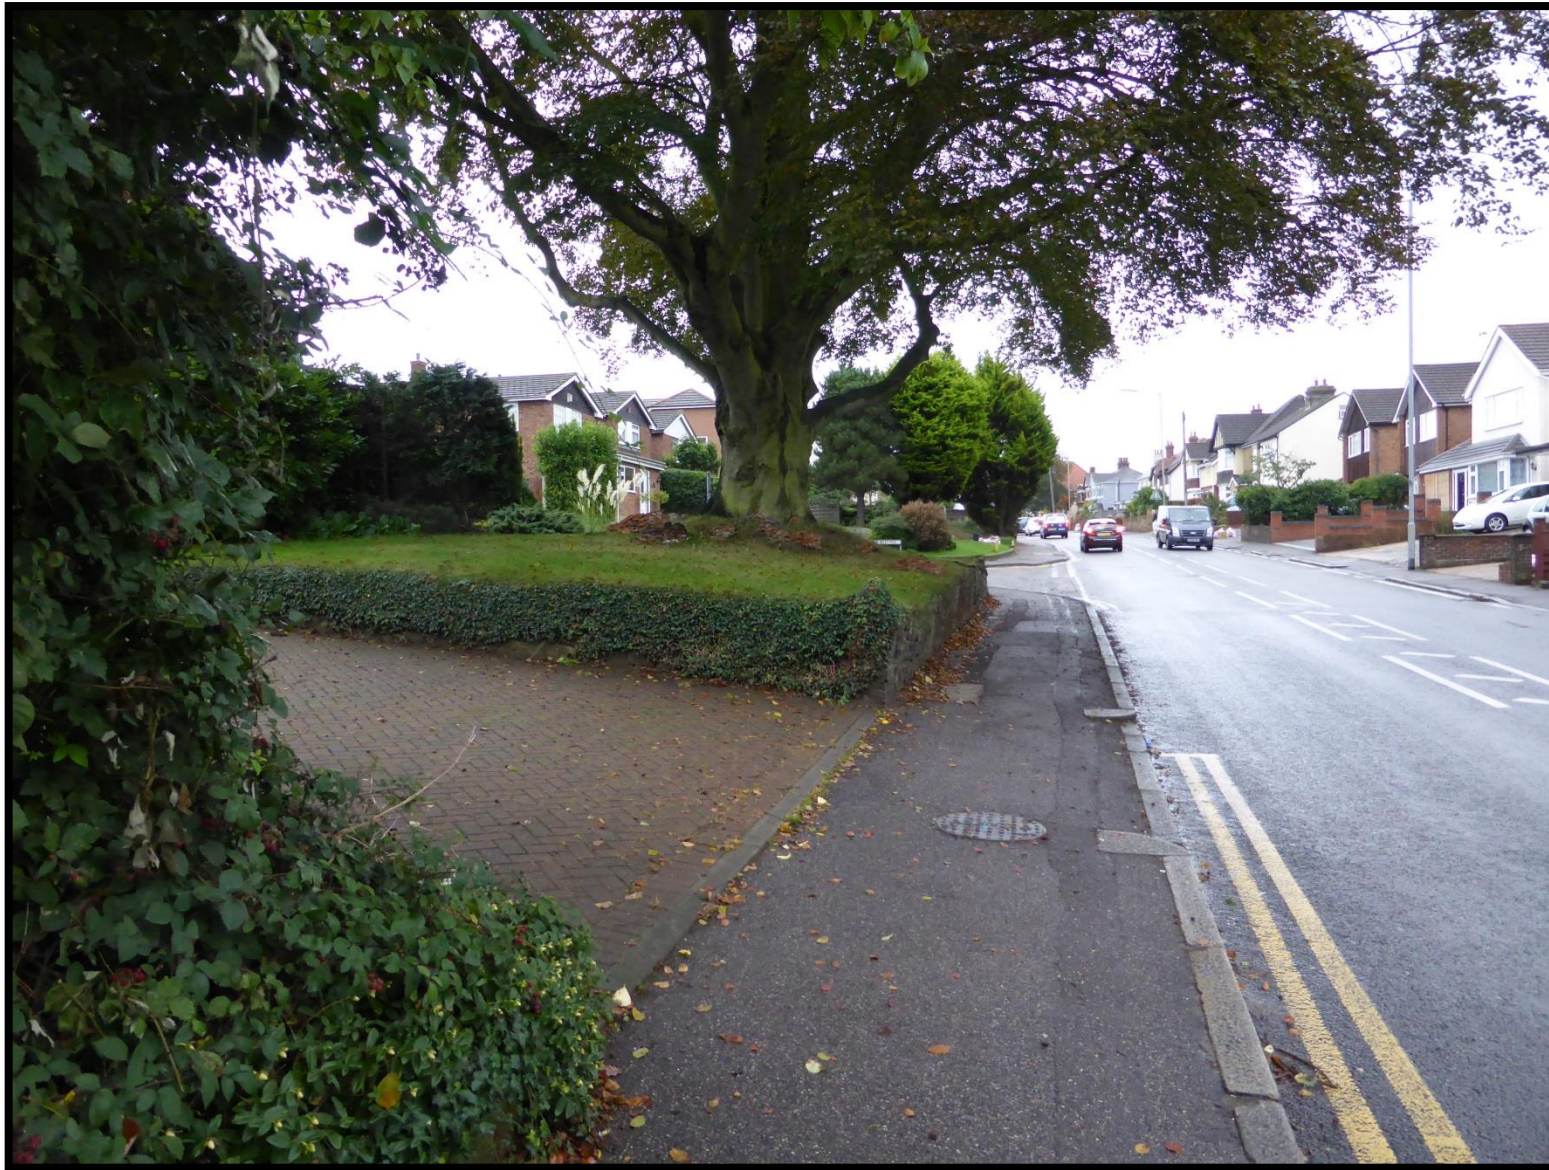
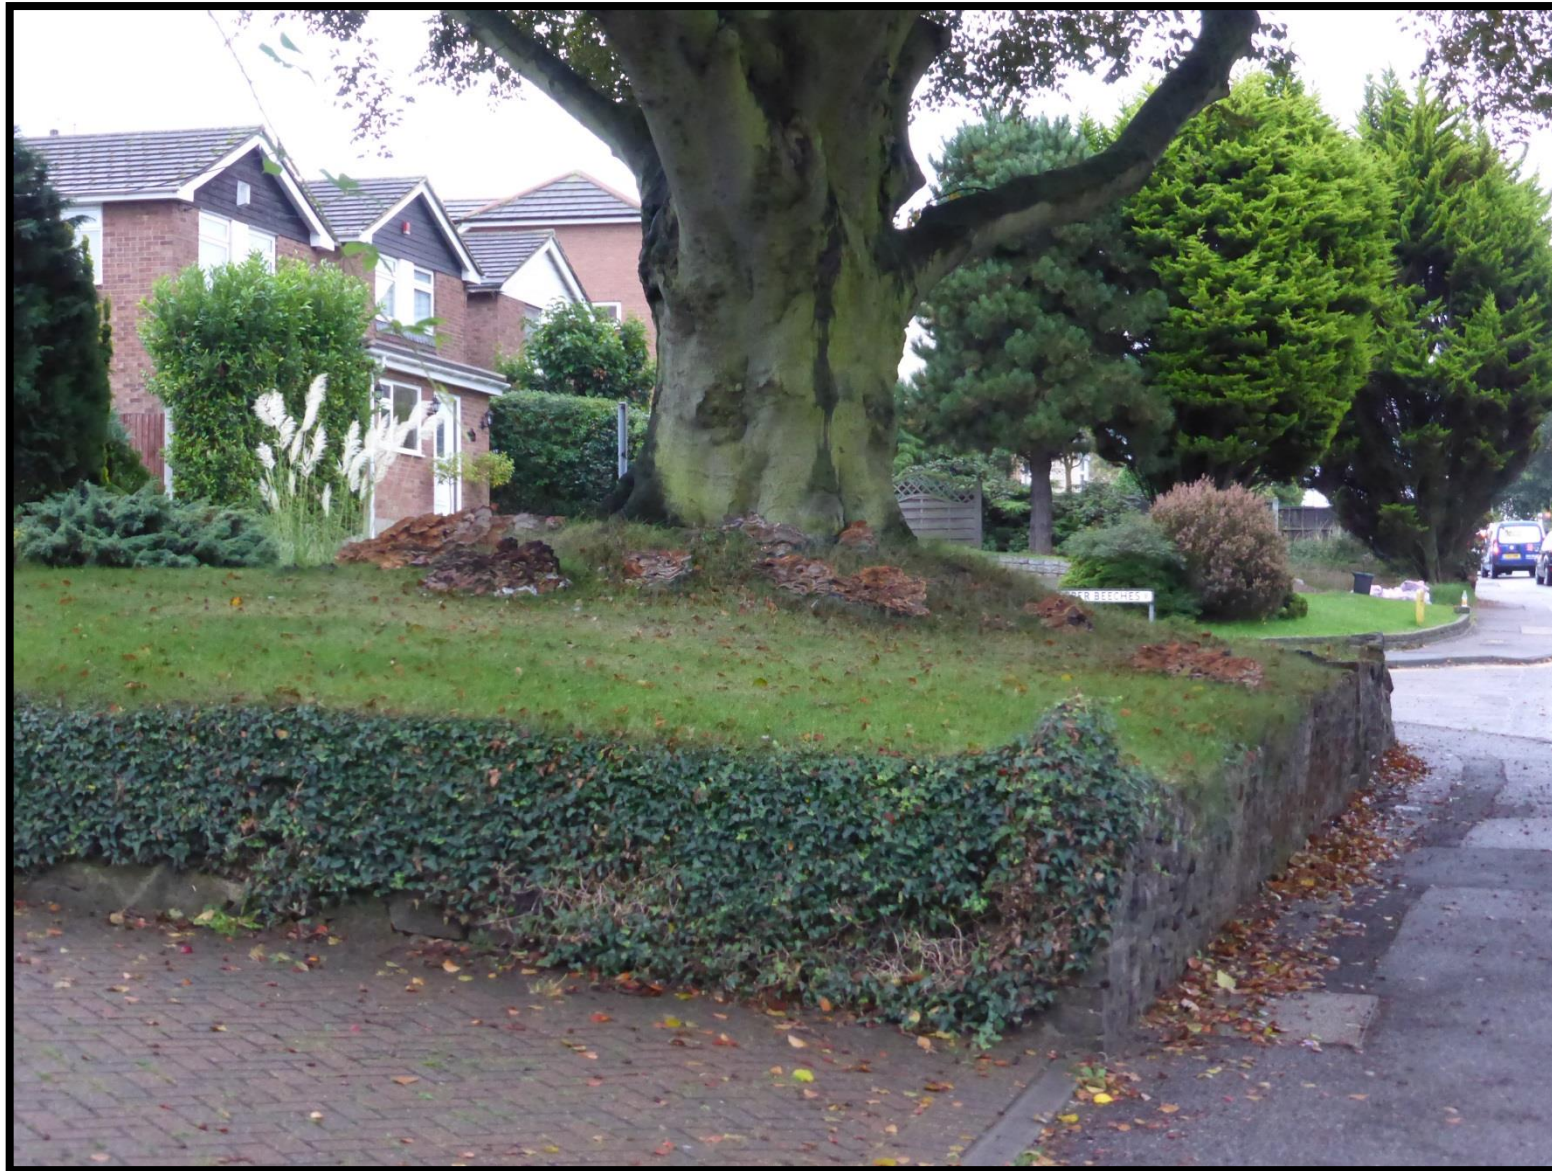
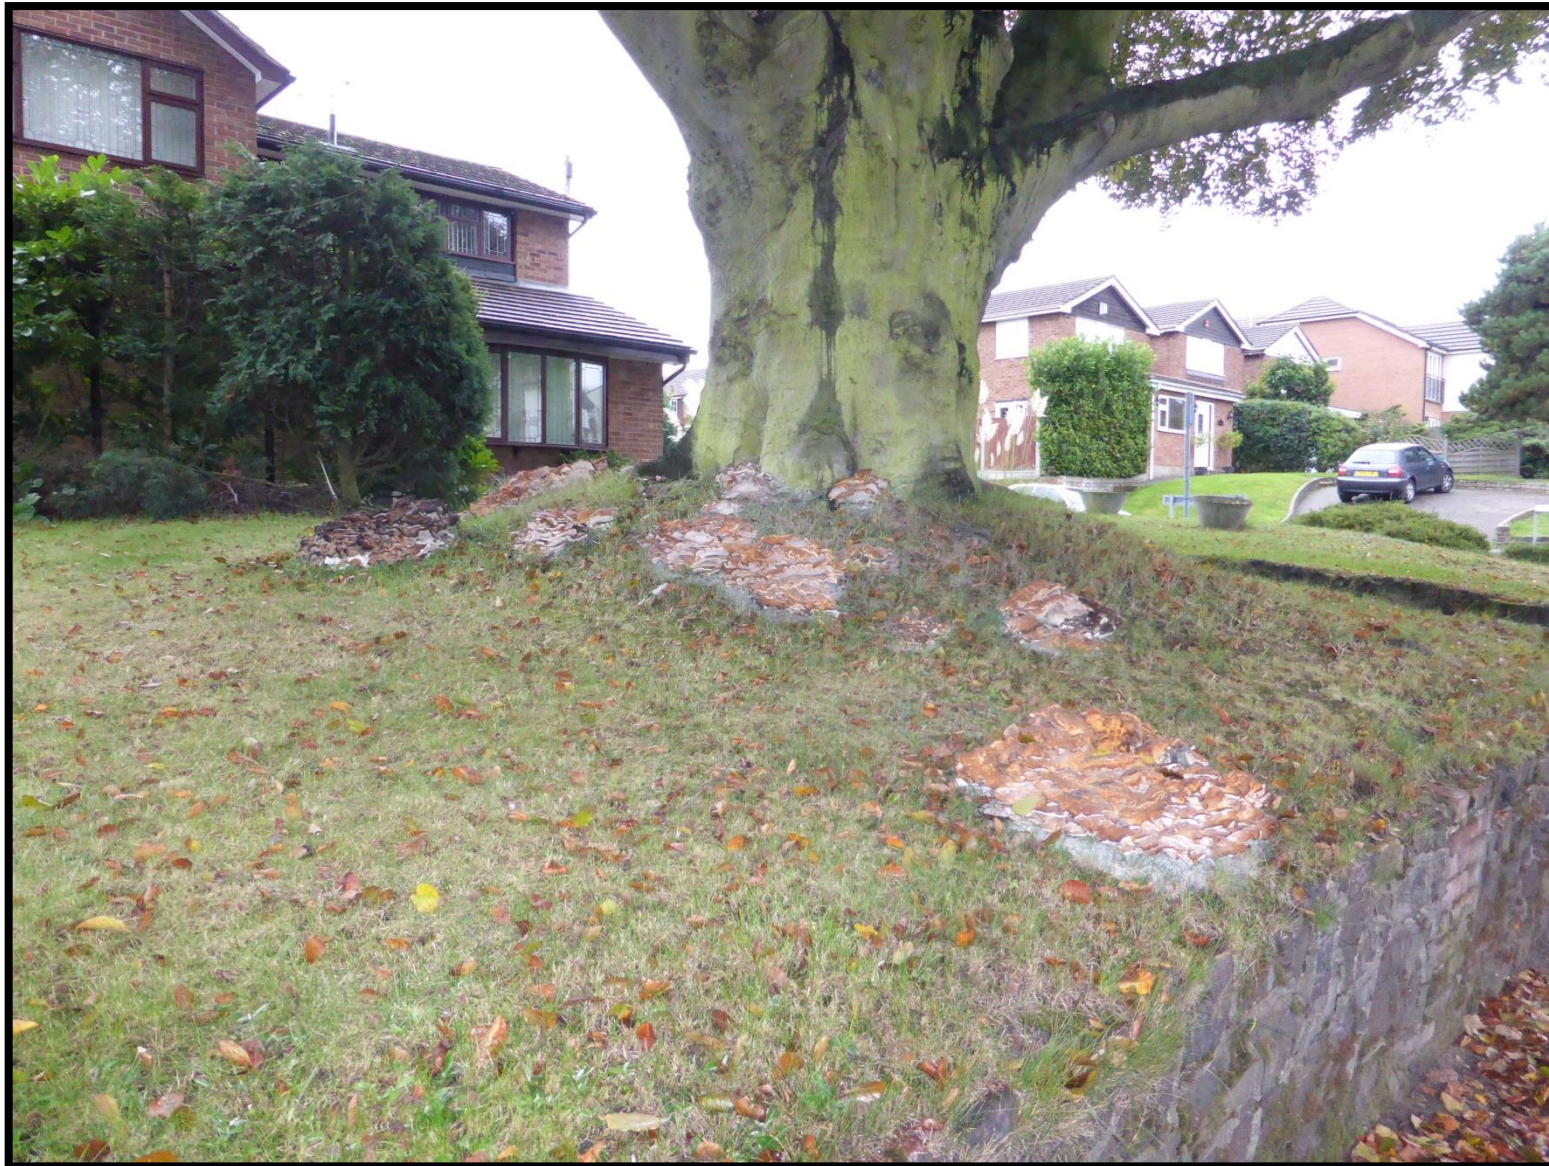
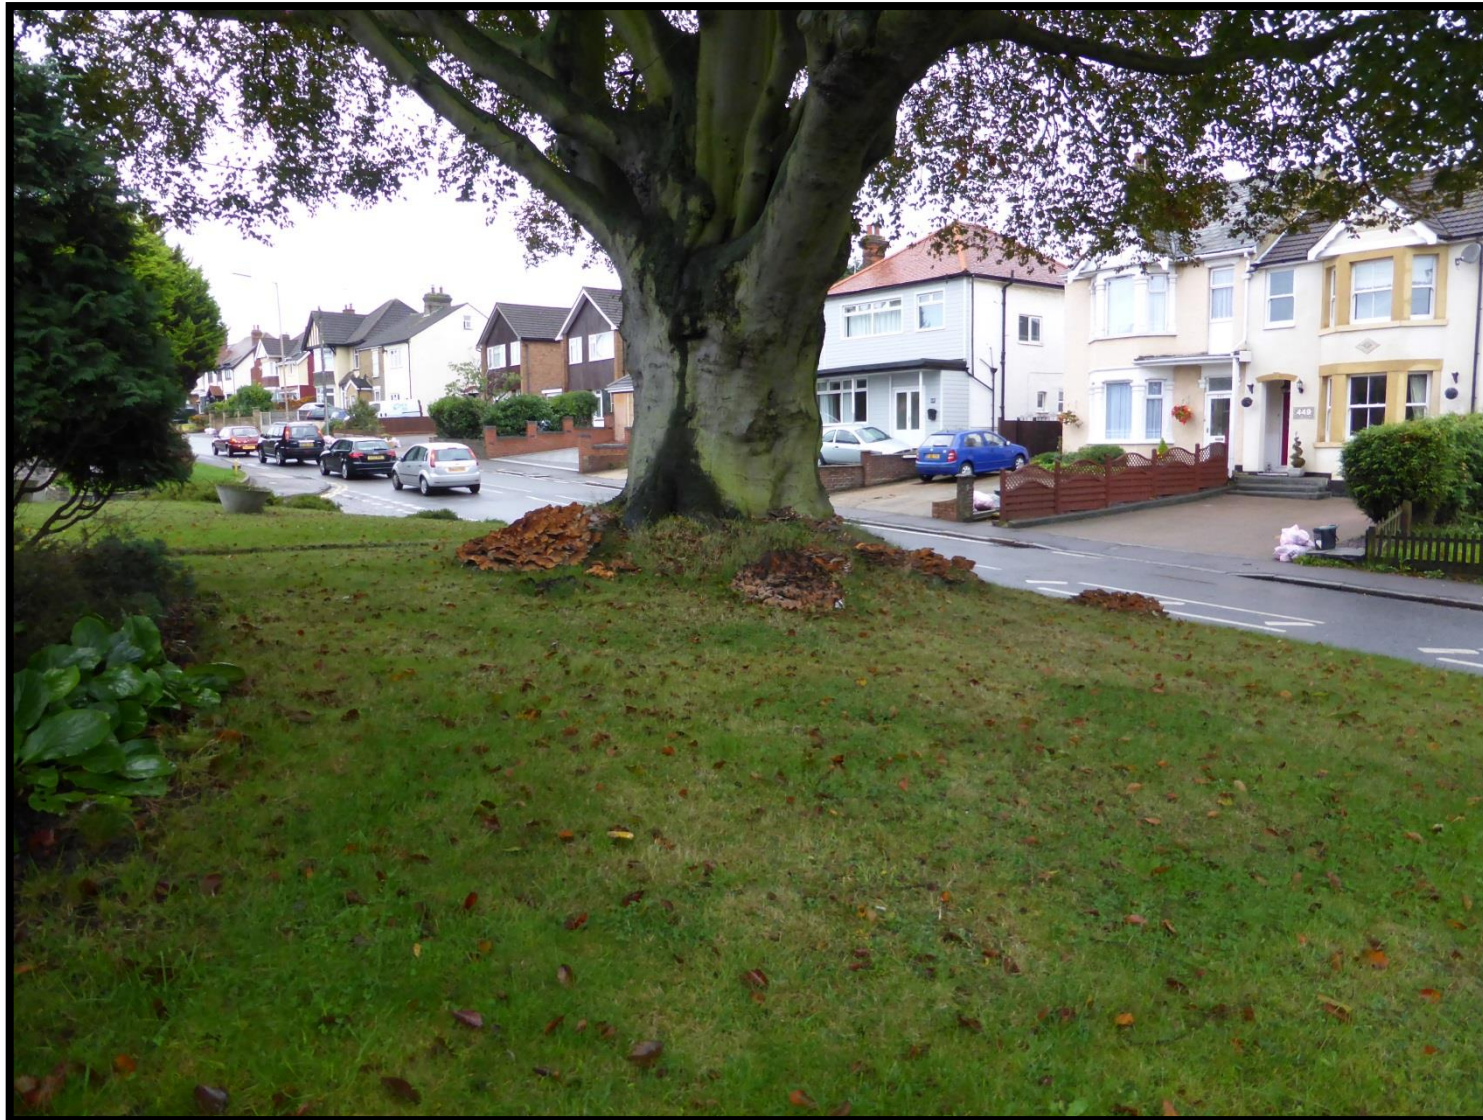
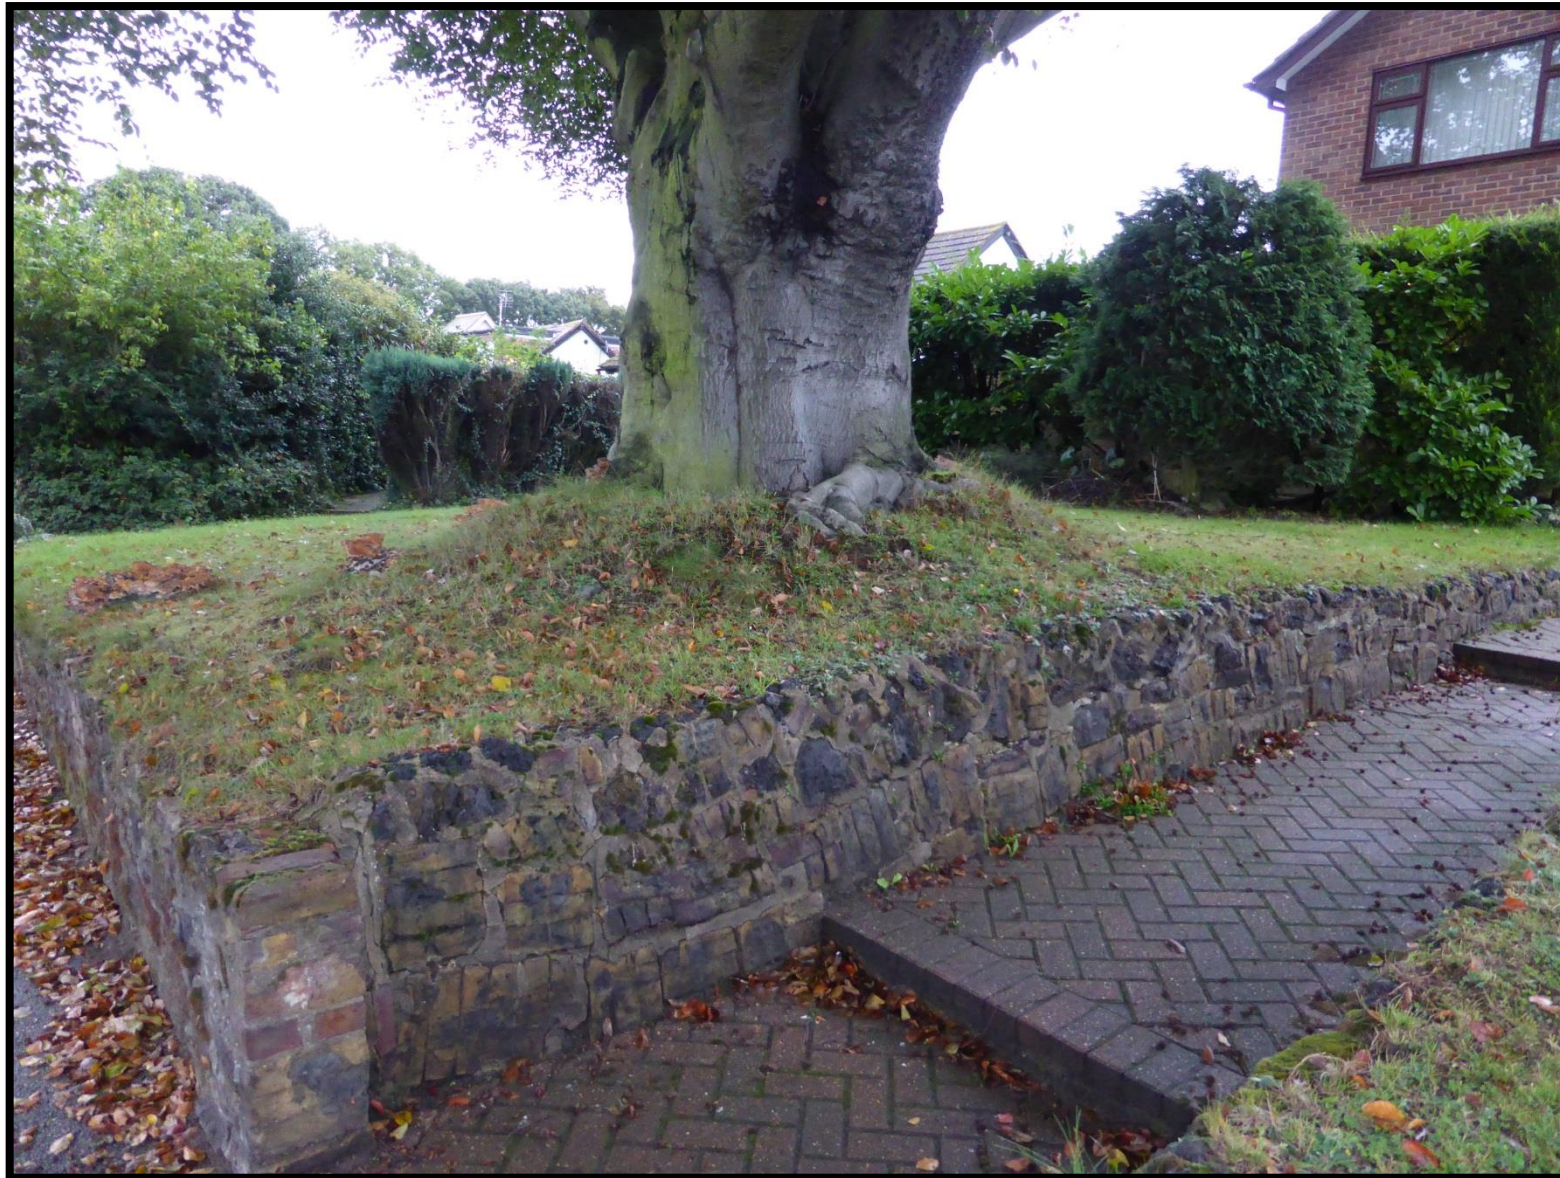
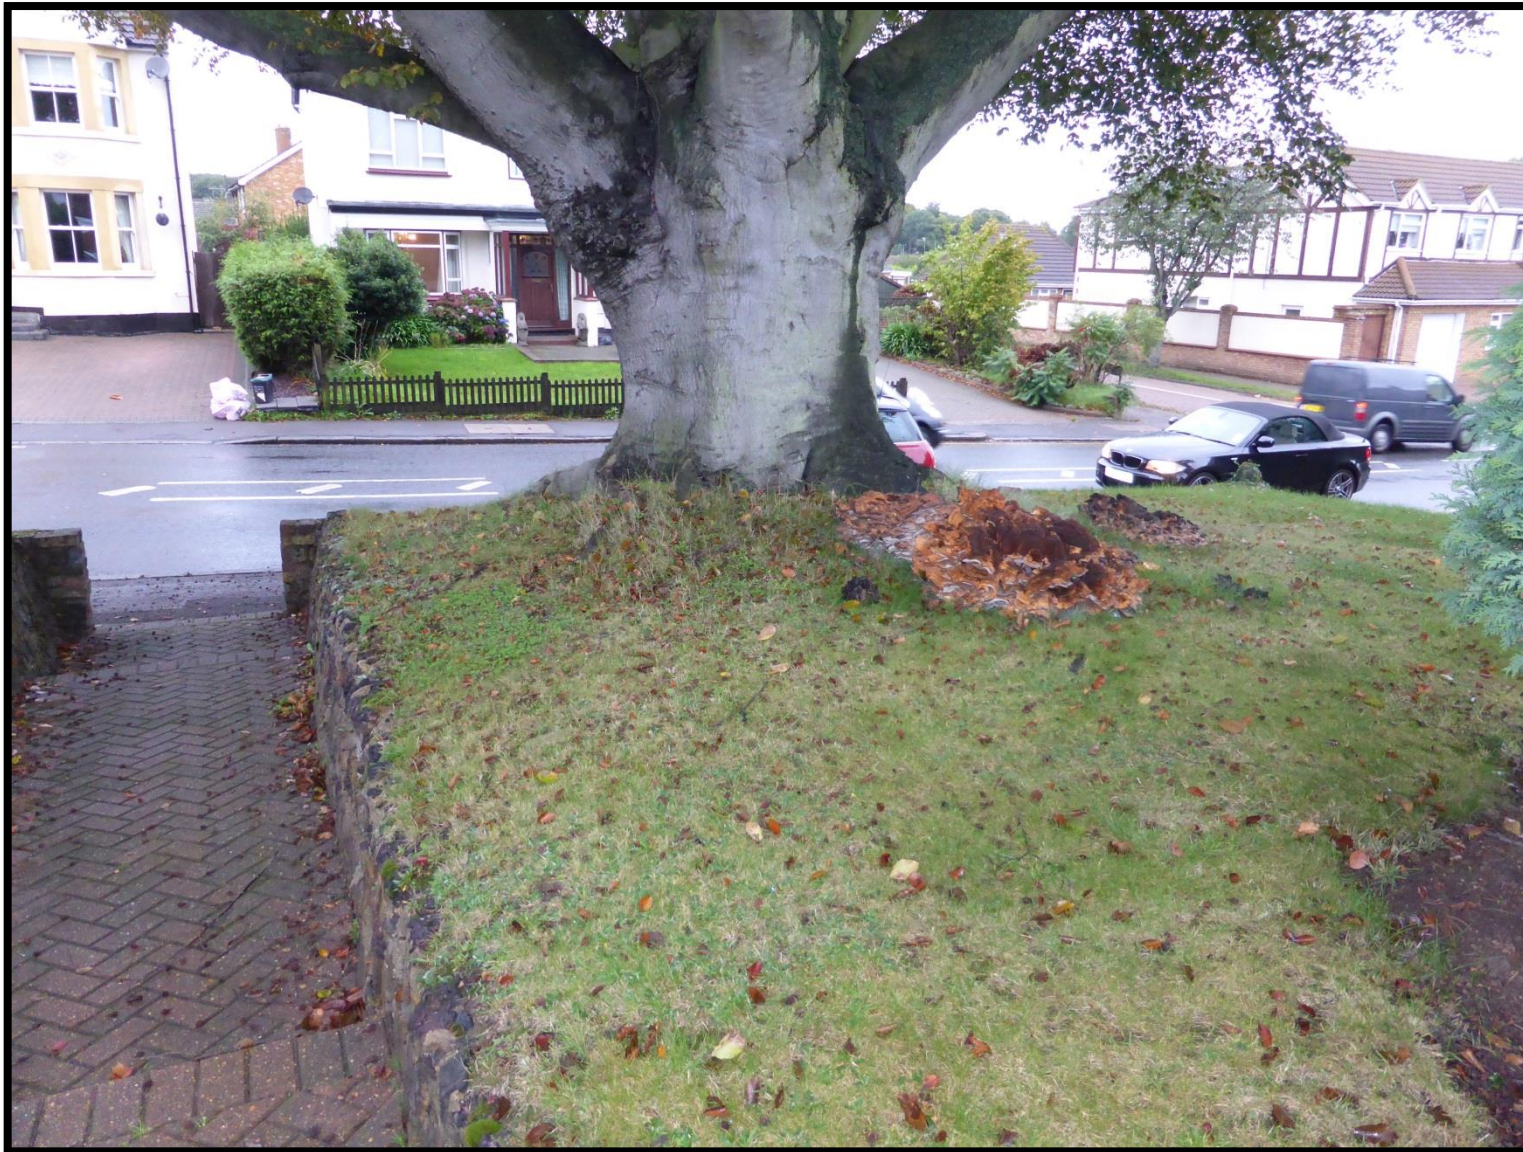
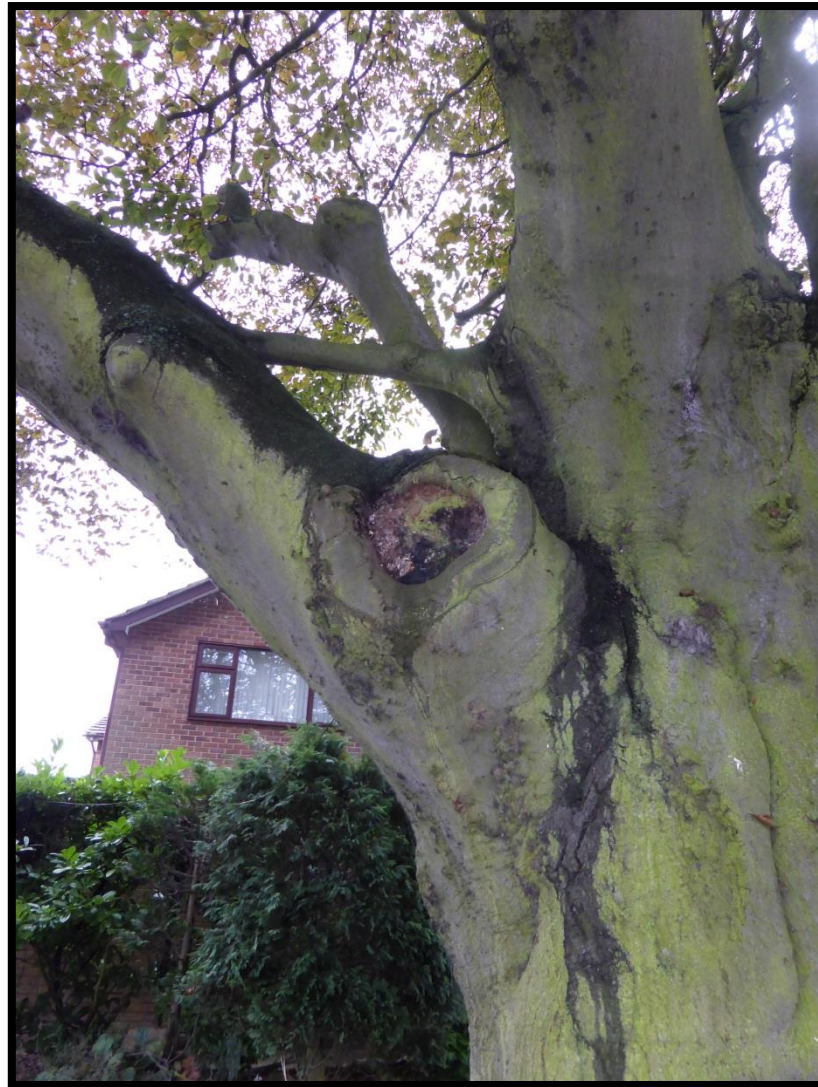
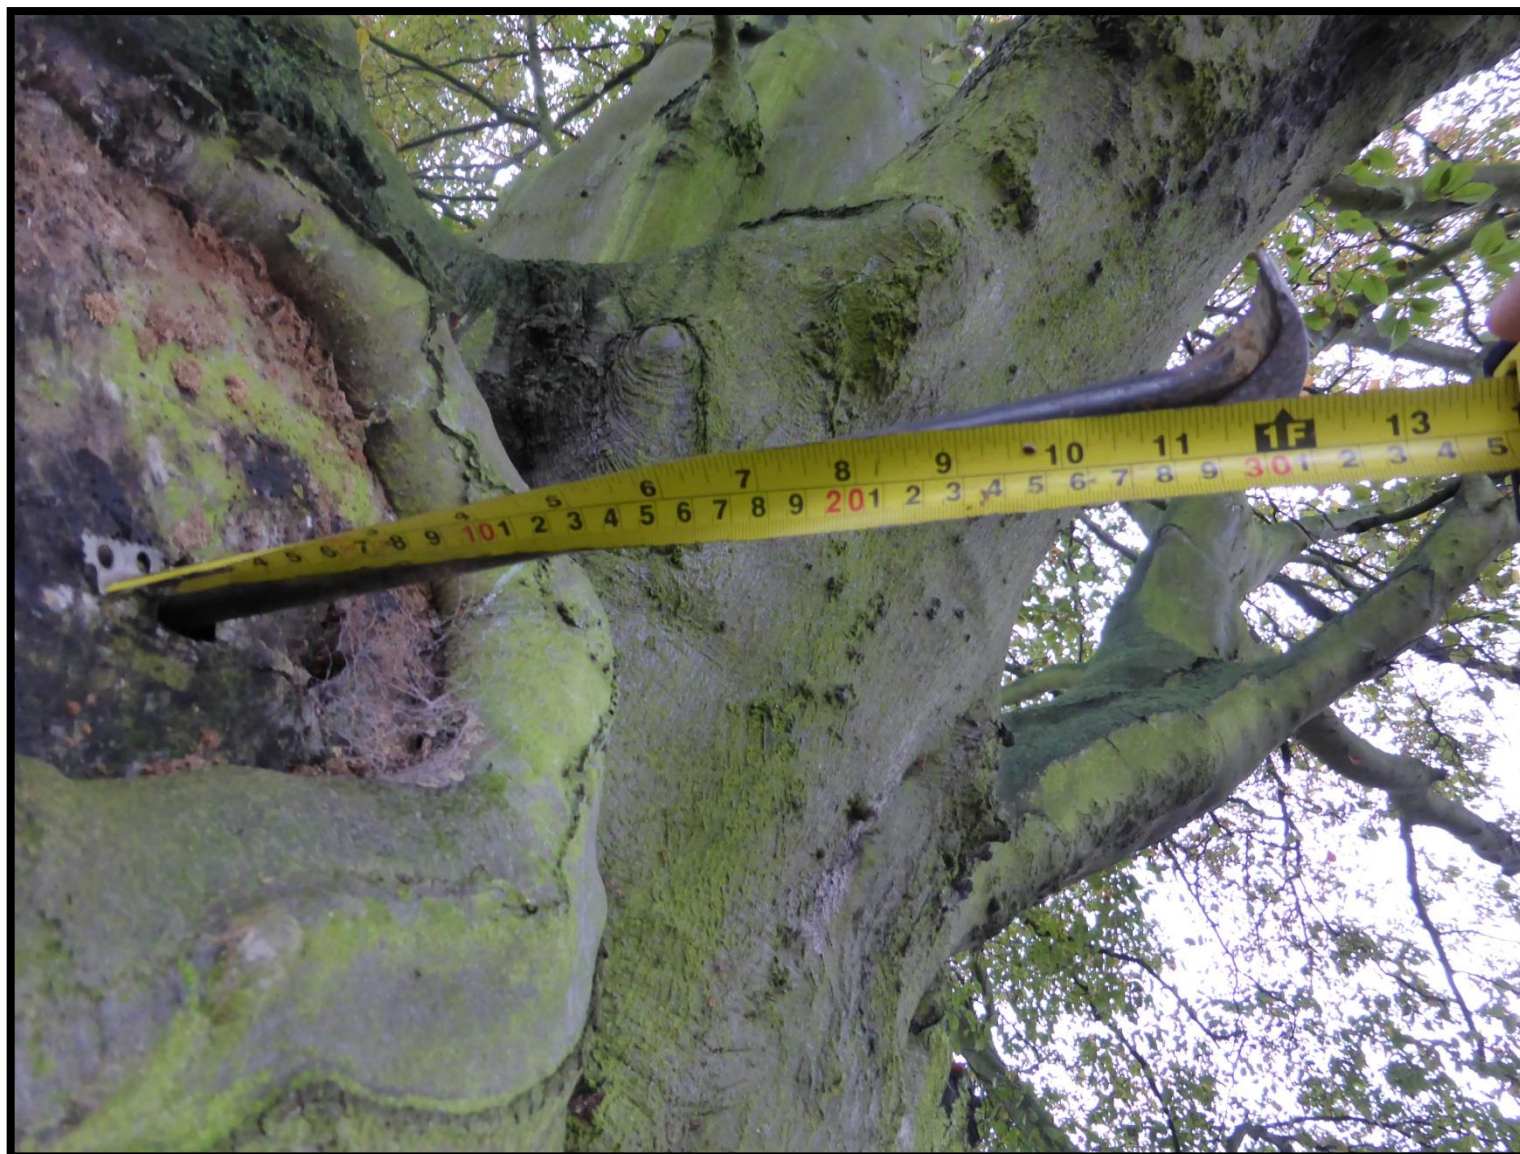
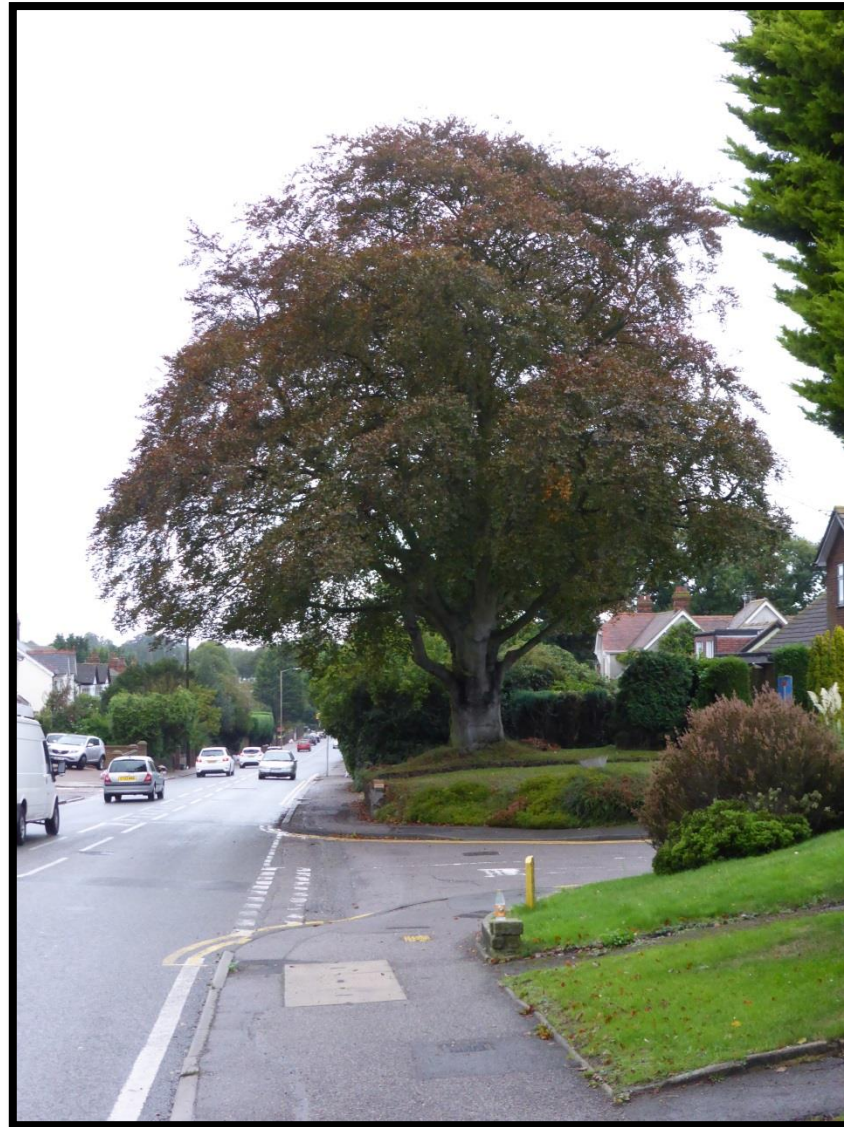
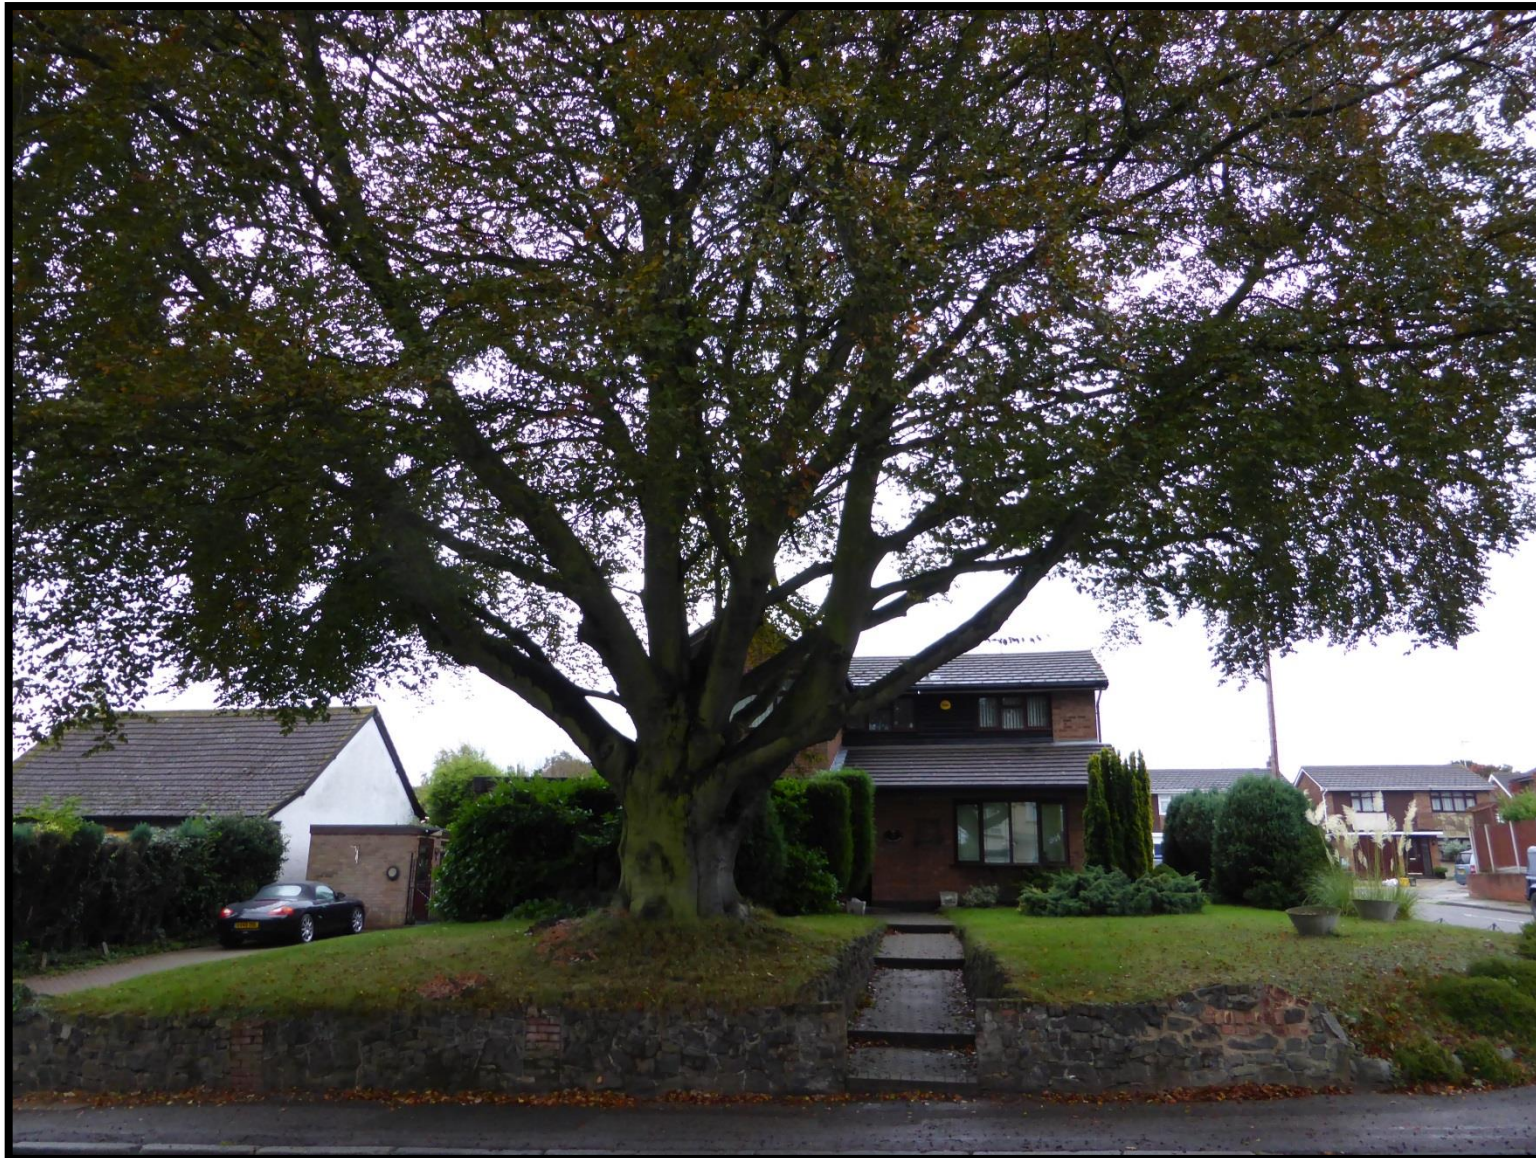
Appendix 3: Photos

Tree No.	Species	Height (M)	Trunk Diameter (MM)	Canopy Spread (M)	Age Class	Physiological Condition	Structural Condition	Comments
1	Copper Beech	16m	1350mm @ 0.25m	N 12.5m E 6m S 11.7m W 10.25	M	Below Average	Hazardous	<p>Situated within the raised front garden of No.1 Copper Beeches, immediately adjacent to the A129 Rayleigh Road; sunken footpath (approx. 700mm below base of trunk) situated within 1.3m from S side of the trunk, public footpath is within 2.25m from W side of trunk (approx. 850mm below trunk), sunken drive situated 6m from N side from trunk (up to 800mm below trunk); multiple (approx. 24) large fruiting bodies, (<i>Meripilus giganteus</i> – giant polypore) situated between the buttress roots and across the ground around $\frac{3}{4}$ of the diameter of the stem extending out by up to 3m radius from the stem; fruiting bodies range young recently emerged to dying and decayed and between 50mm X 50mm up to 1000mm; short squat trunk growing on a mound of earth within a reasonably level garden; appearance of a graft point at approx. 0.5m above ground level; multiple stemmed from 1.25m; security light fixed to the trunk on the E side of the trunk which is partially occluded; large wound on west side of N limb at union with trunk, hollow sounding when struck with acoustic hammer, metal probe pushed into wound with no resistance up to 300mm (approx. half depth of limb); one sided canopy to the N, S & W, E canopy has been reduced; above average dead wood and hung up deadwood in canopy; slightly sparsely foliated; below average leaf size; tip dieback throughout canopy; of low quality, of moderate to high value; of only limited potential.</p> <hr/> <p>Fell to ground level.</p>
