**SAYERS FARM HADLEIGH  
ESSEX**

**Built Heritage Appraisal**

On behalf of:  
**Essex County Council**

Report reference: 79790.01

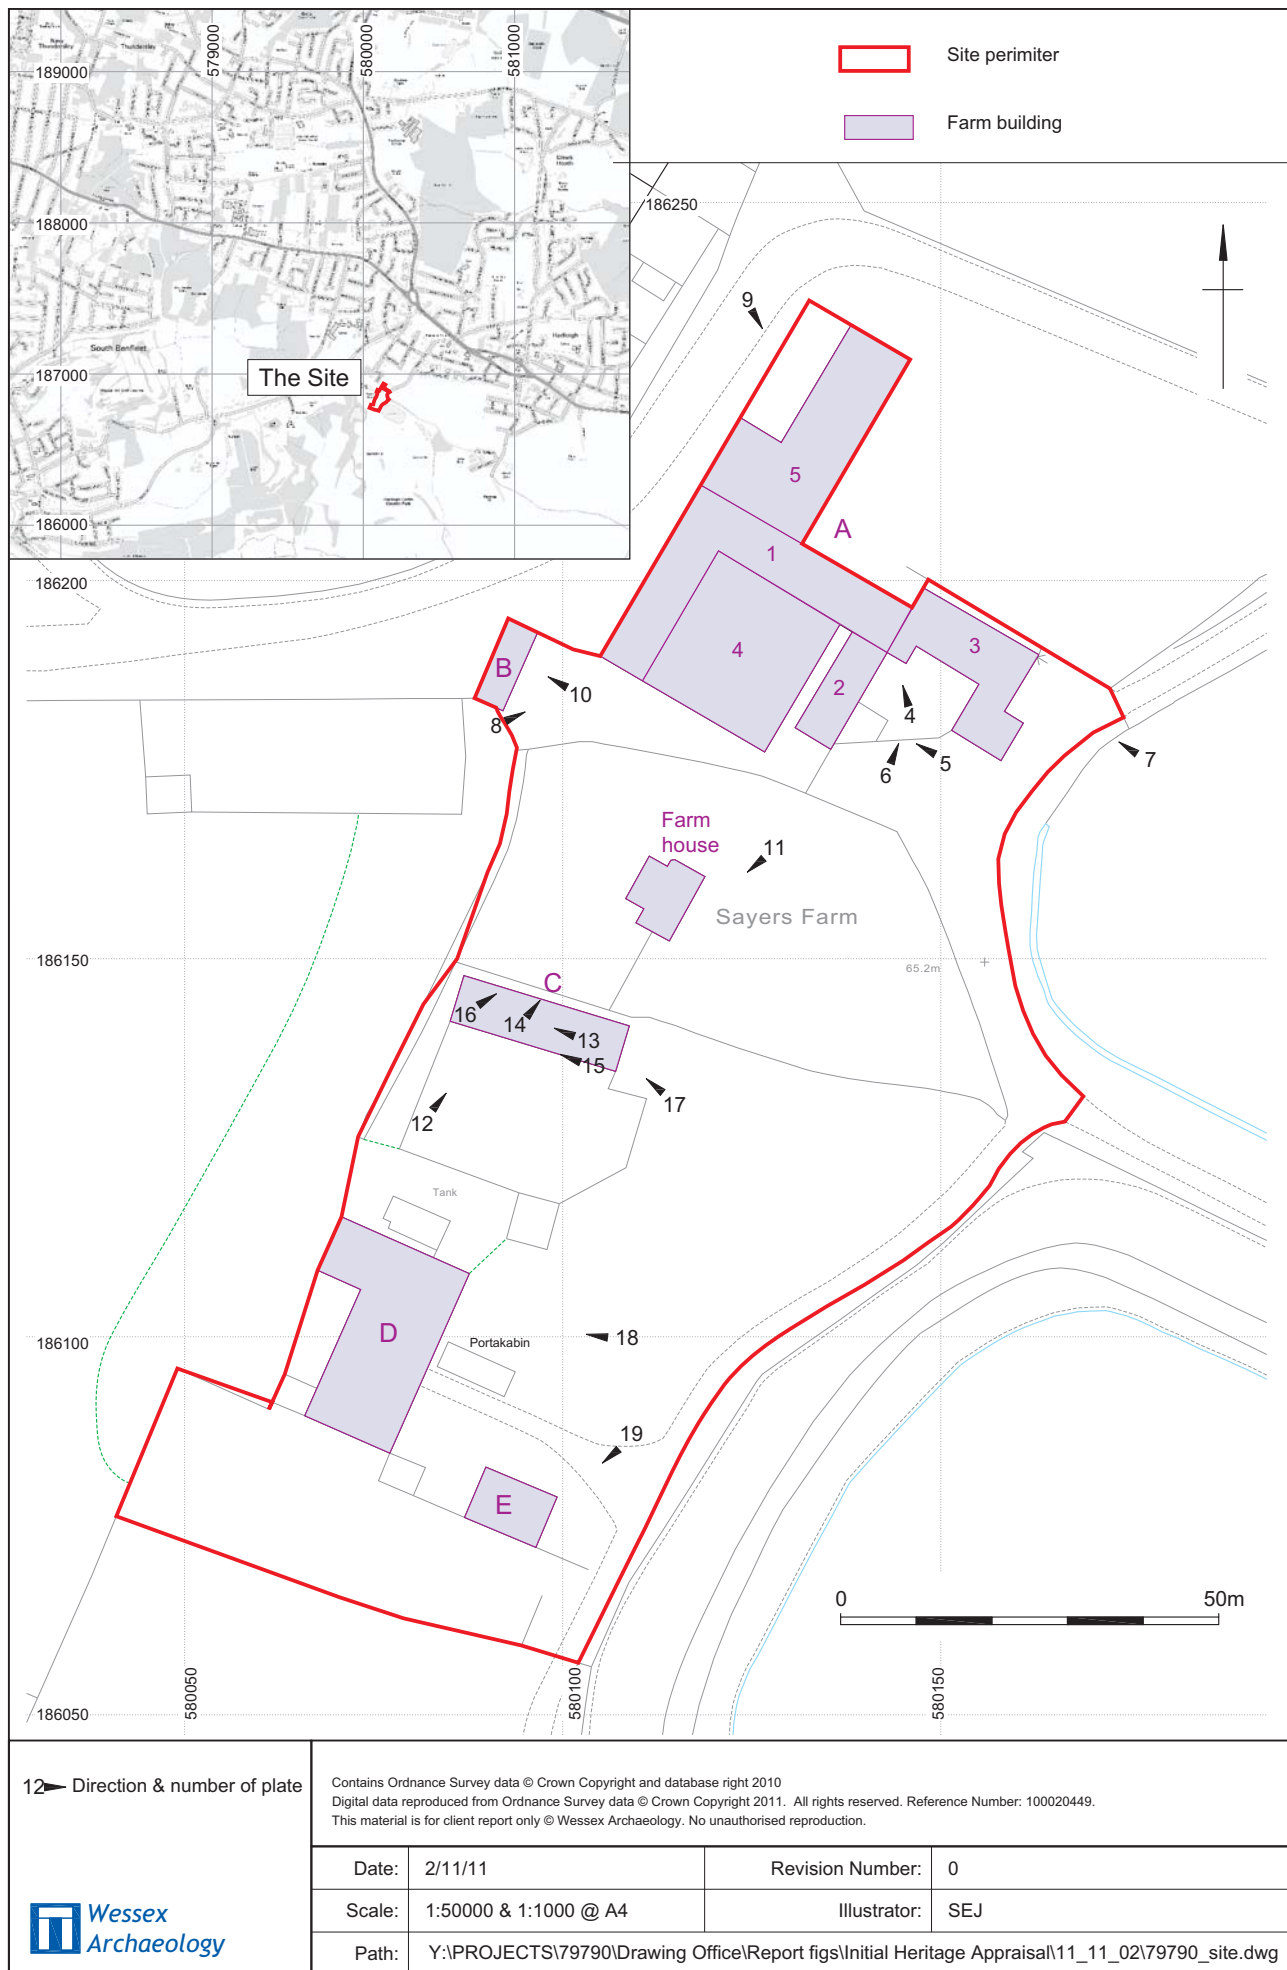
Figure 1

Site location showing building allocations and direction of plates

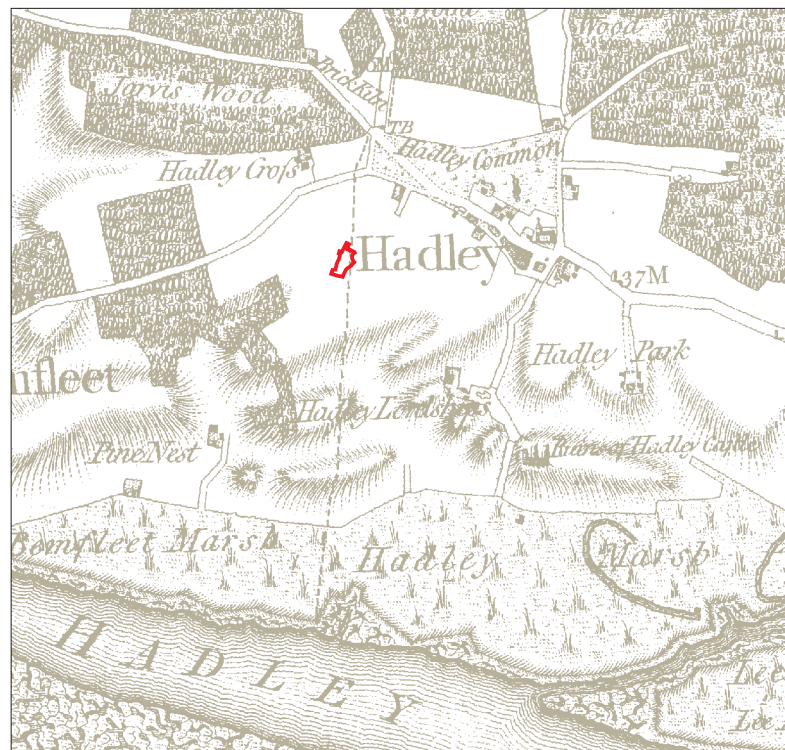
3.1.1 The earliest map showing Hadleigh is John Chapman and Peter Andre's map of Essex dated 1717 (**Figure 2**). This is a relatively detailed map showing towns, principal roads and farms. 'Hadley', as it was called then, is clearly shown as is 'ruins of Hadley castle'. To the north-west of the castle is a farm, at this time called 'Hadley Landships'. It is thought that this is the present Castle Farm. Sayers Farm is not shown so it is likely that it is not yet built.

John Chapman and Peter Andre's 1777 map

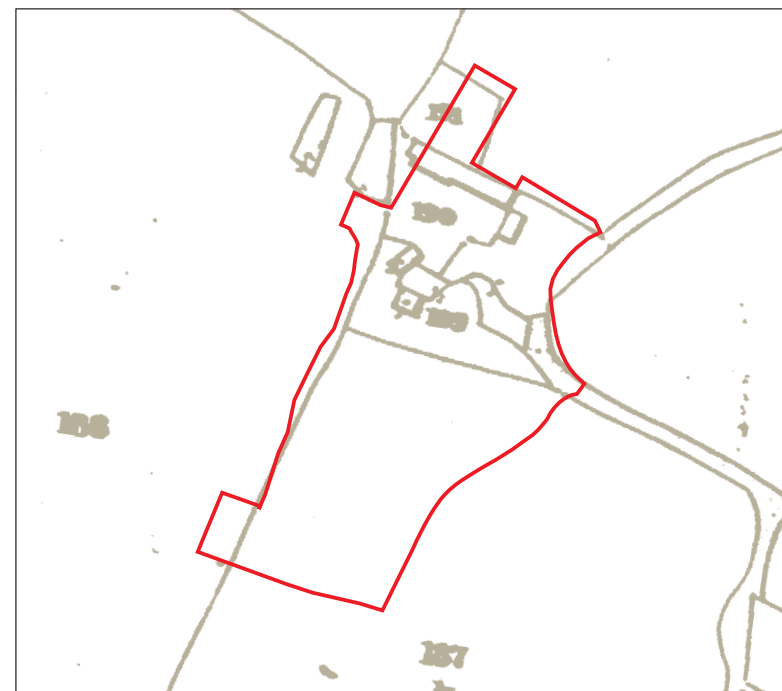
- 3.1.2 By 1840 it appears that Sayers farmhouse and some other buildings were built (**Figure 2**). The 1840 Tithe map shows the farmhouse located to the south of the farmyard and there are three other buildings depicted, one just to the north-west of the farm house, one long range across the yard to the north and a small structure at its east end. What appear to be ponds or enclosures are also shown to the north-west.

c.1840 Tithe map

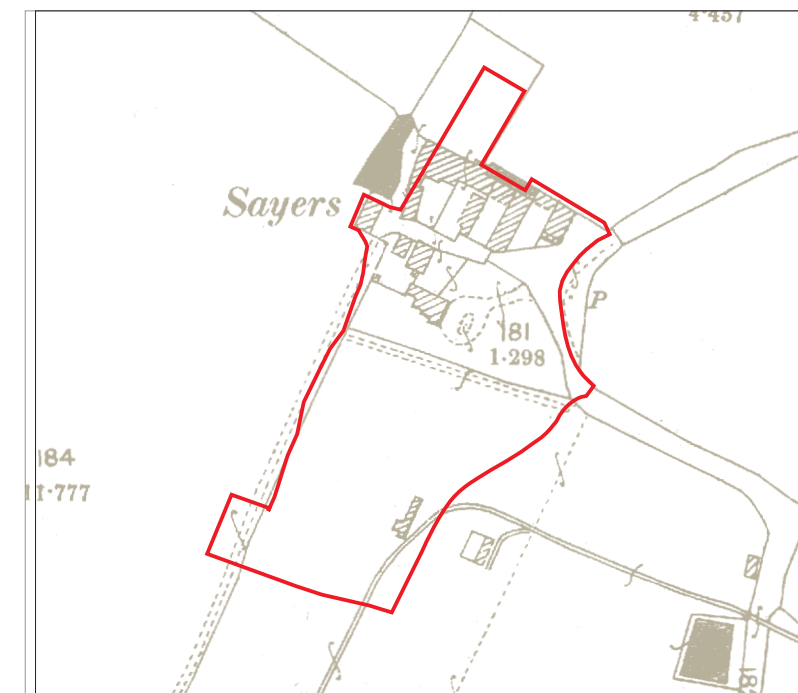
- 3.1.3 By the time of the 1896 Ordnance Survey map, the building complex at Sayers Farm is shown fully developed with the farm house and farm buildings in extensively their present form (**Figure 2**). Sayers Farm was, by now, part of the Salvation Army's Farm Colony set up by William Booth (Parkhill and Cook 2008). The main role of Sayers Farm was the dairy, supplying the colony with its milk and dairy products and also supplying to commercial dairies. The 1840 layout had been expanded with several additional buildings built across the original yard on a north-south axis. To the west, the stable block is shown on the south side of a pond.

- 3.1.4 To the south of Sayers Farm the map shows the beginnings of the brickworks which were to dominate this part of the area for some time (**Figure 2**). Tram lines, a possible chimney and kiln are shown as is a long rectangular building to the south. Snipes Lane is shown as the eastern boundary to the brickworks.

1896 Ordnance Survey map (2nd edit.)

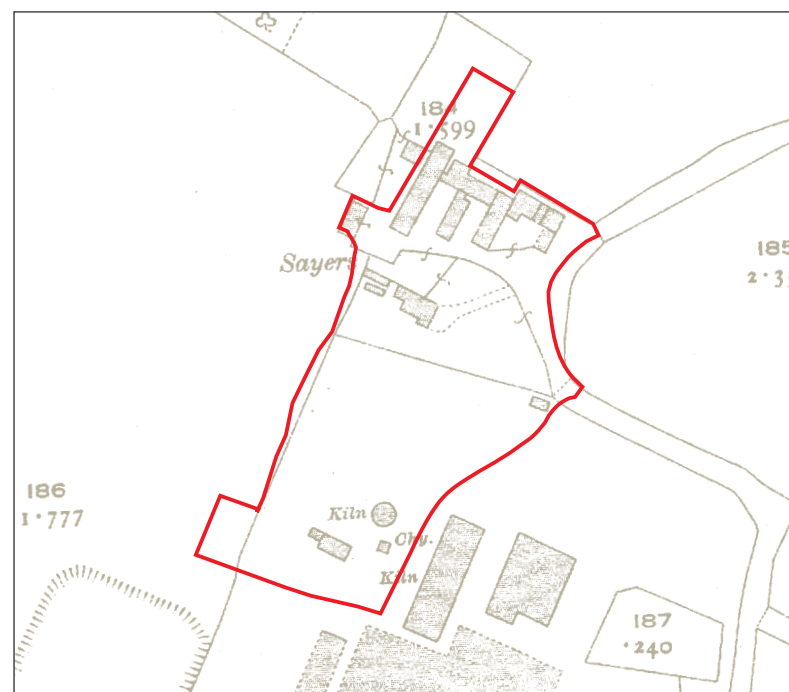
- 3.1.5 By 1923 the OS map shows little has changed to Sayers Farm (**Figure 2**). The farm buildings have not changed but two structures have been demolished to the north-west of the house. Two smaller buildings have been built immediately to the west of the house.

1923 Ordnance Survey map (3rd edit.)

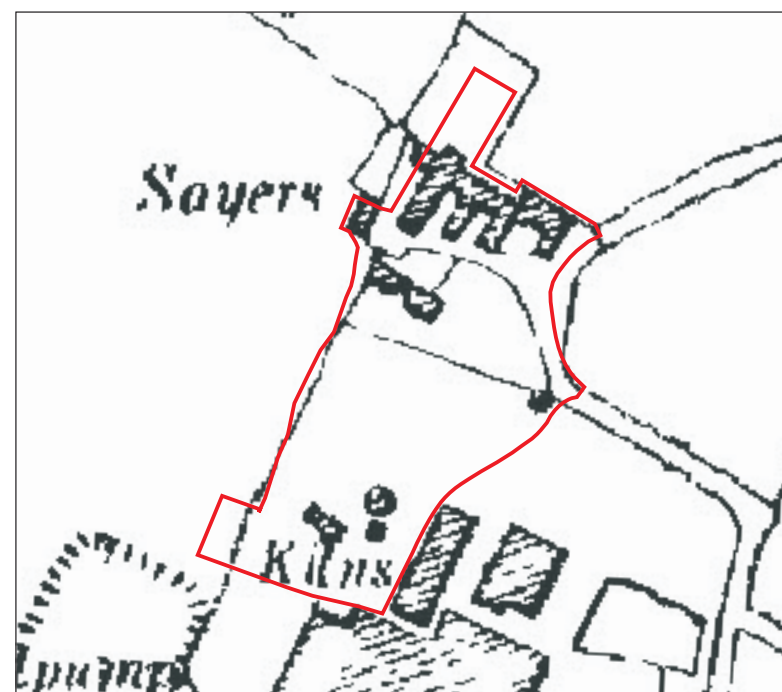
- 3.1.8 The Ordnance Survey map dated 1938-47 does not show the gun emplacements or the camp associated with them (**Figure 2**). This is not unusual given the sensitive nature of the site. It does show the farm and brickworks as little changed.

1938-47 Ordnance Survey map

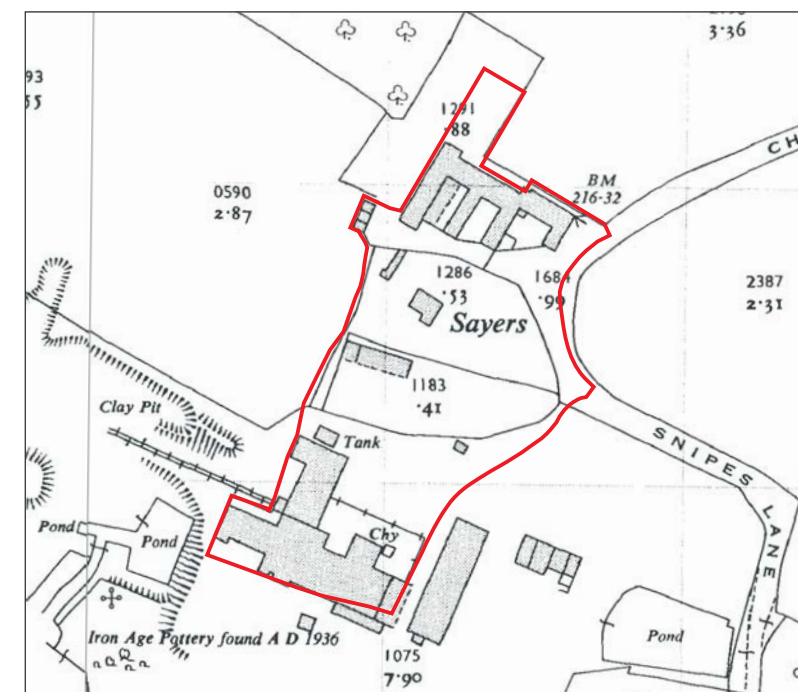
1955-6 Ordnance Survey map

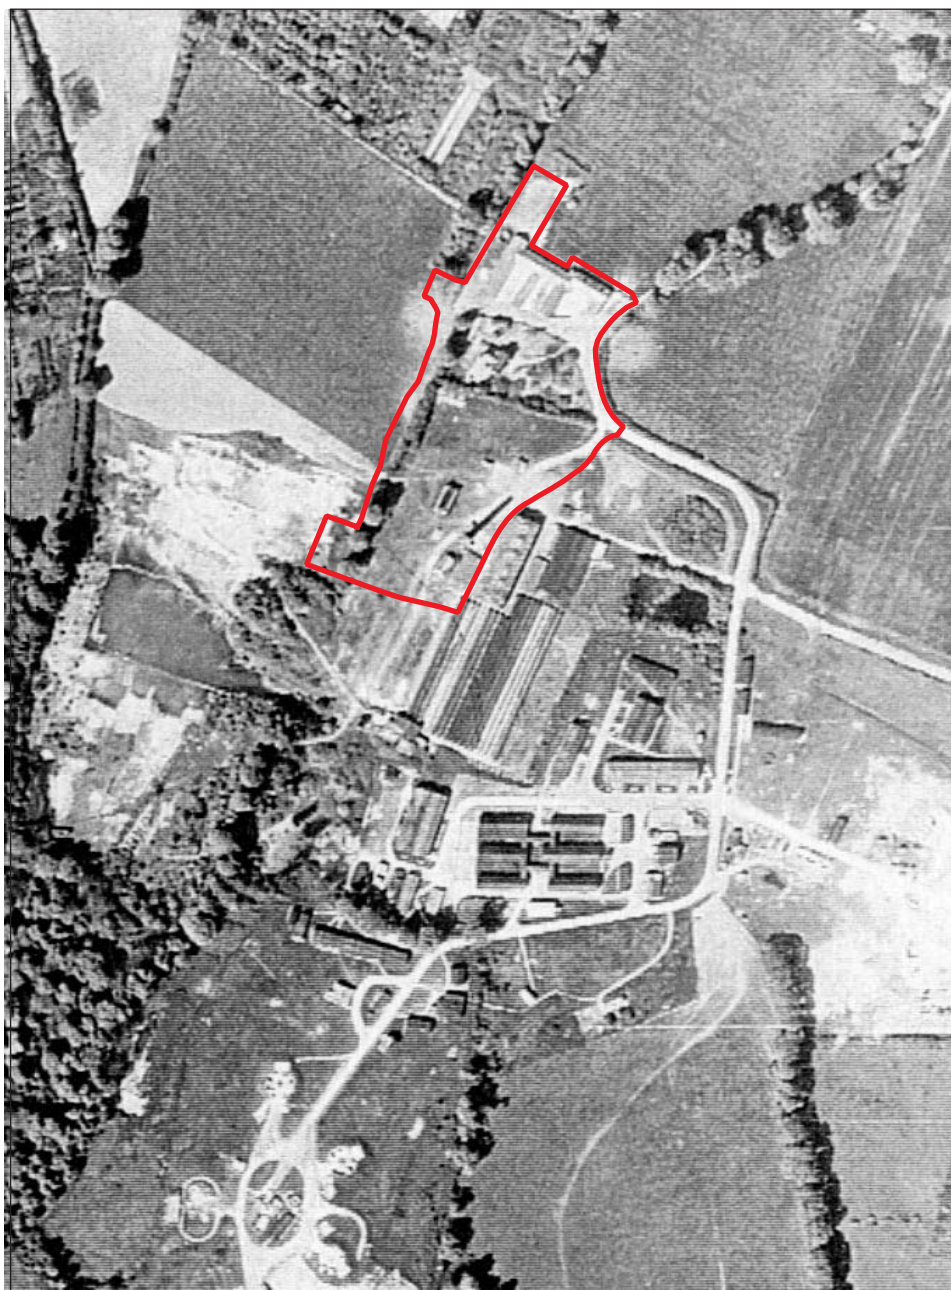
Plate 1: 1946 RAF aerial photograph

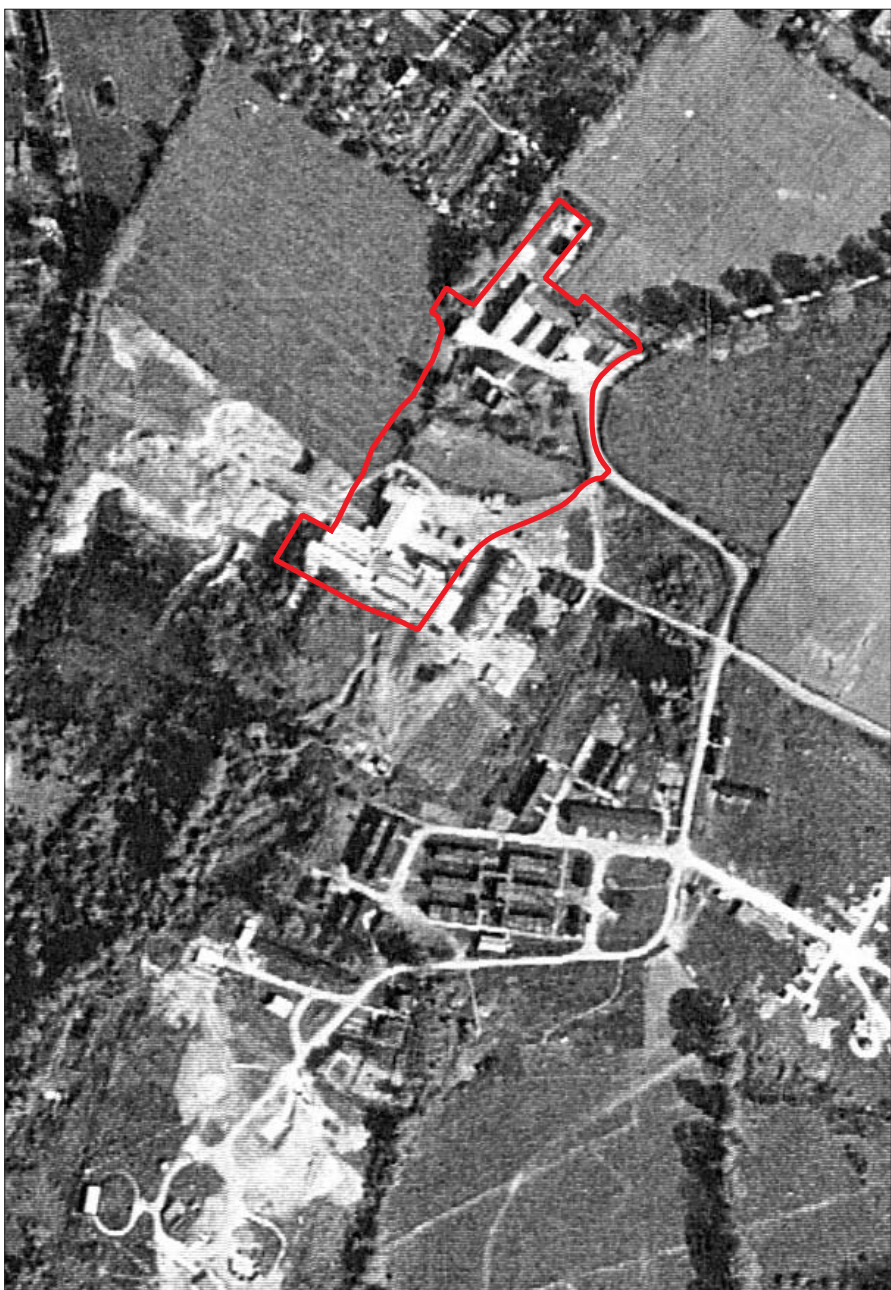
- 3.1.10 An aerial photograph taken in April 1952 clearly shows that building C has not yet been built (**Plate 2**). Sayers Farm is shown with little or no change.

Plate 2: 1952 RAF aerial photograph

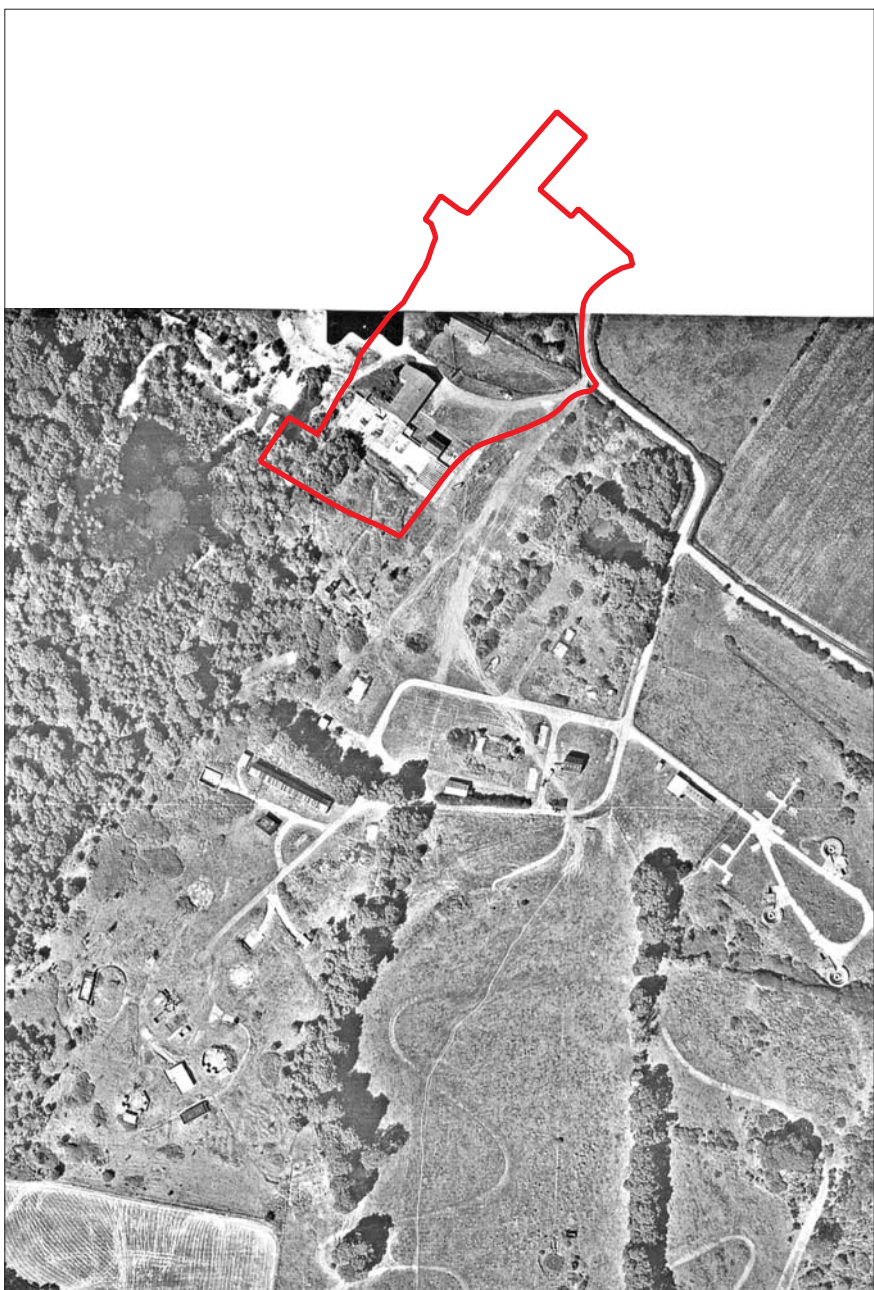
Plate 3: 1964 Ordnance Survey aerial photograph
